BRINK INSPECTIONS, LLC

1234 Main Street
Columbia, TN 38401

1: Inspection Detail	6
2: Roof	8
3: Exterior	15
4: Basement, Foundation, Crawlspace & Structure	38
5: Electrical	42
6: Plumbing	48
7: Attic, Insulation & Ventilation	51
8: Bathrooms	53
9: Doors, Windows & Interior	58
10: Laundry	62
11: Kitchen	64
12: Heating, Cooling, Distribution	68
Standards of Practice	75

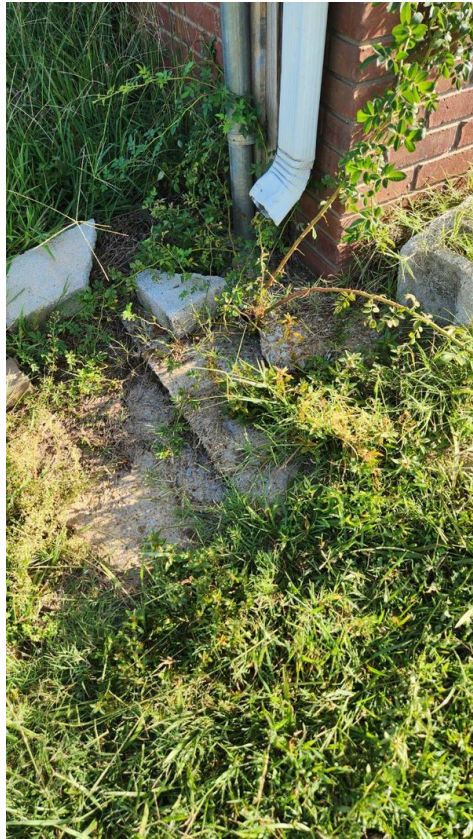
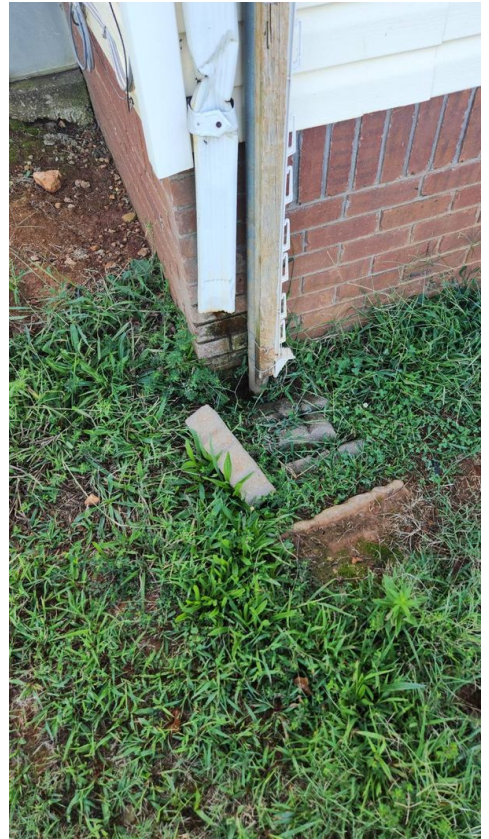
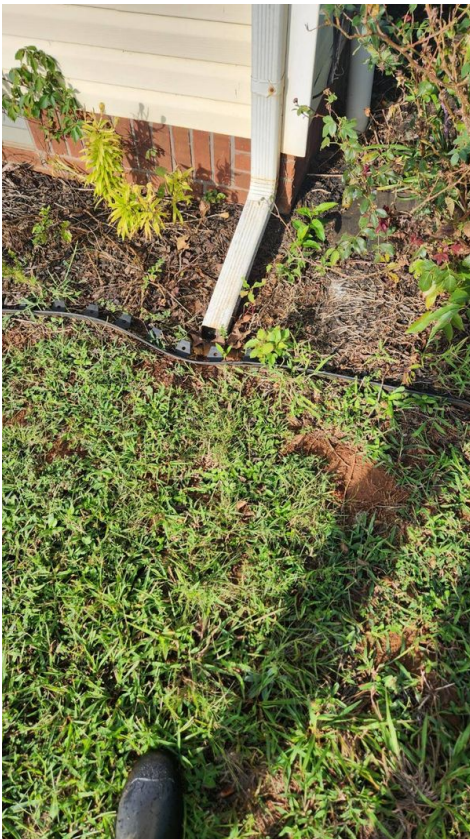
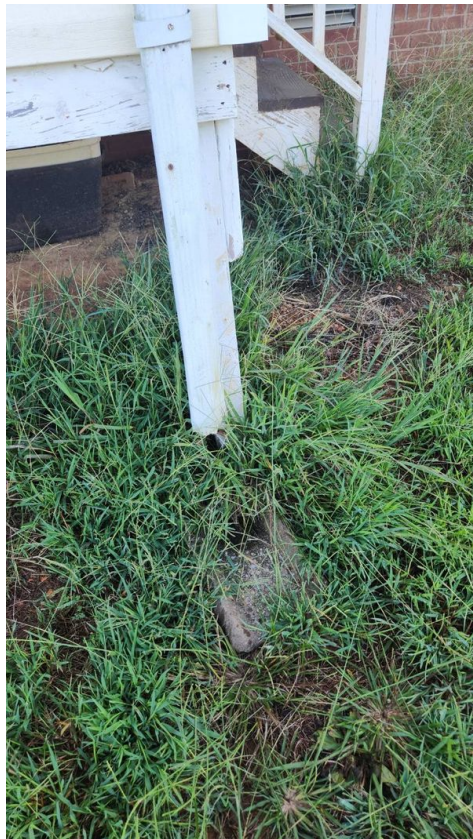
One or more downspouts drain too close to the home's foundation. This can result in excessive moisture in the soil at the foundation, which can lead to foundation/structural movement. Recommend adjusting downspout extensions to drain at least 6 feet from the foundation. A handy homeowner should be able to do this project.

Recommendation

Contact a handyman or DIY project

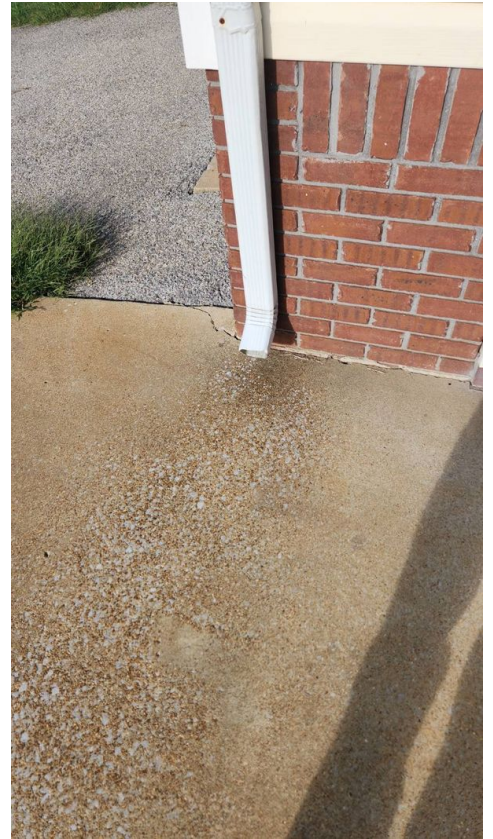
2.5.2 Gutters & Downspouts

DOWNSPOUTS TERMINATE ON HARDSCAPE

Downspouts were present that were terminated on asphalt, concrete, or masonry surface. This can cause a fall/slip hazard in freezing temperatures due to the water from the downspout freezing. Repairs or modifications are recommended to be conducted as needed by a qualified person to divert the downspouts to an area that will not create a hazard.

Recommendation

Contact a qualified handyman.

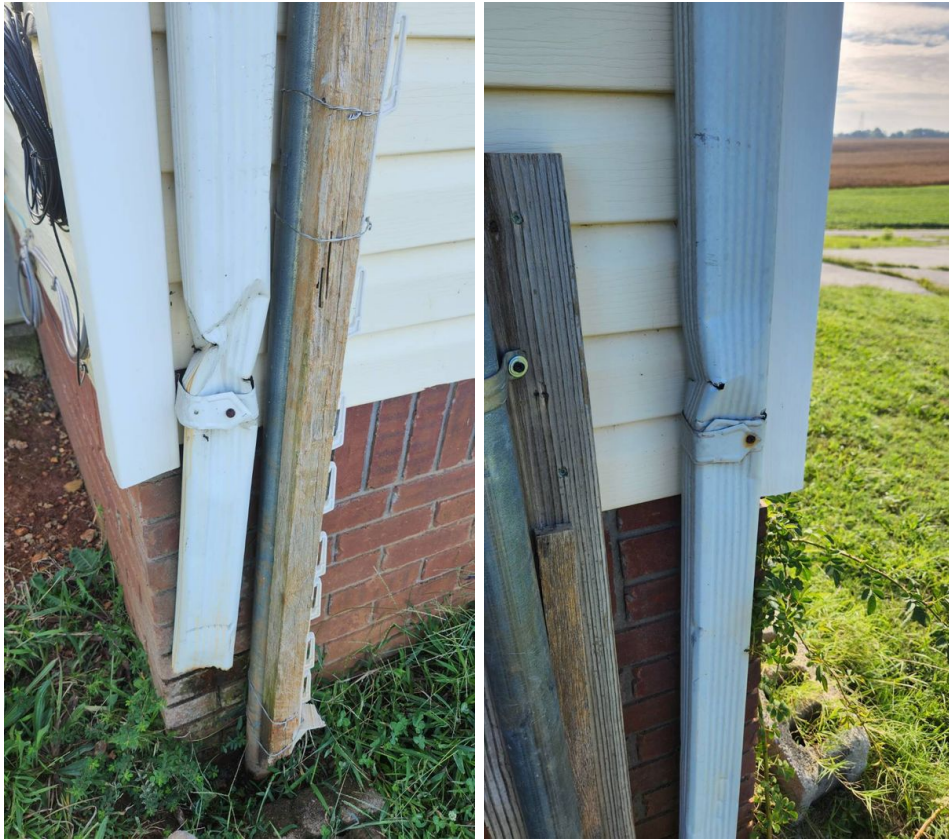
2.5.3 Gutters & Downspouts

DOWNSPOUT DAMAGED

Observed some downspouts that were damaged. Recommend replacing the damaged downspouts so that rainwater can drain properly. Qualified professional can be contacted or handyman/DIY.

Recommendation

Contact a qualified professional.

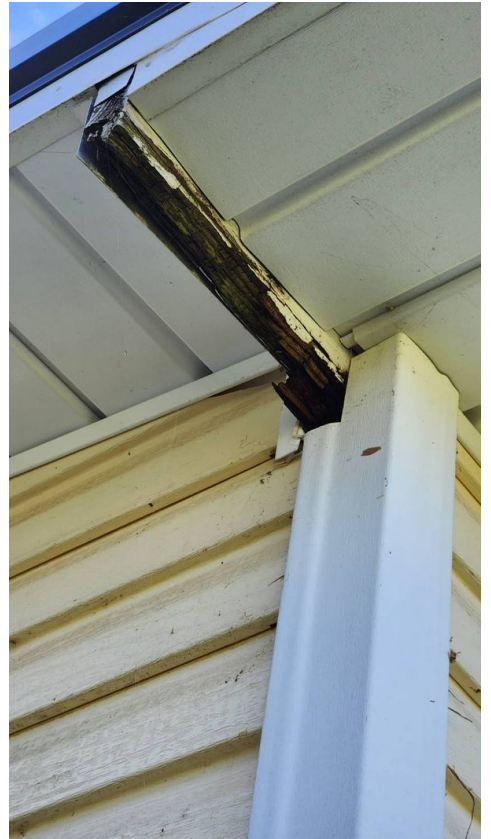
3.2.2 Eaves, Soffits & Fascia

DAMAGE OBSERVED AT SOFFIT

Recommendation

Contact a qualified roofing professional.

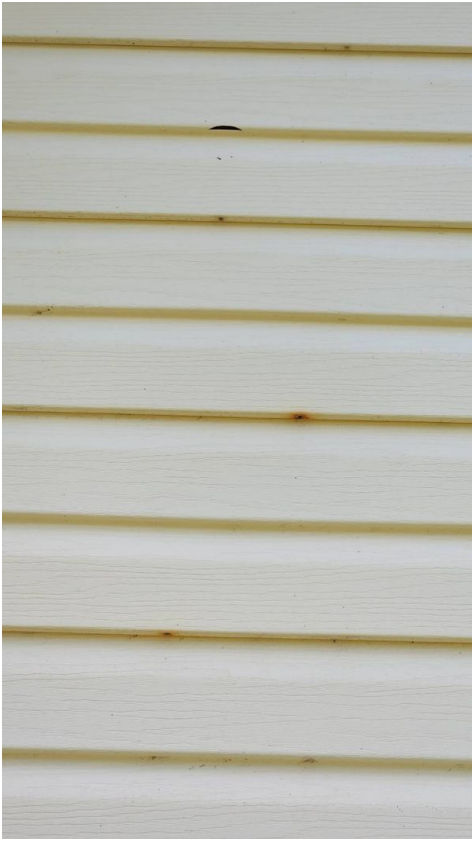
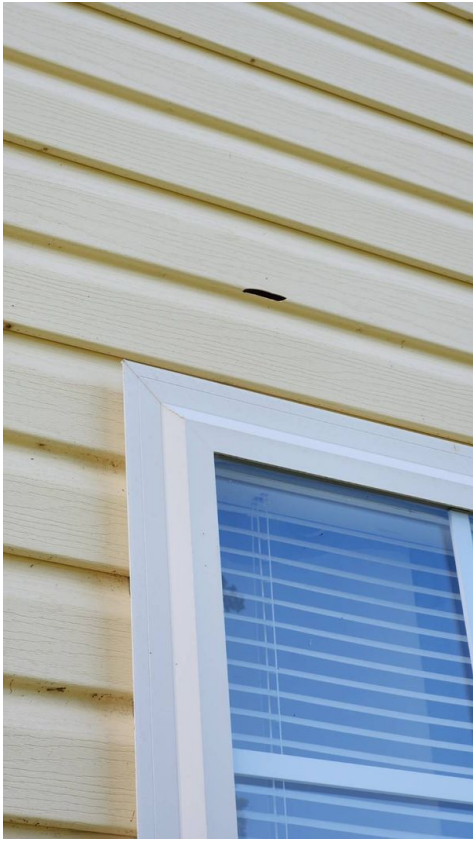
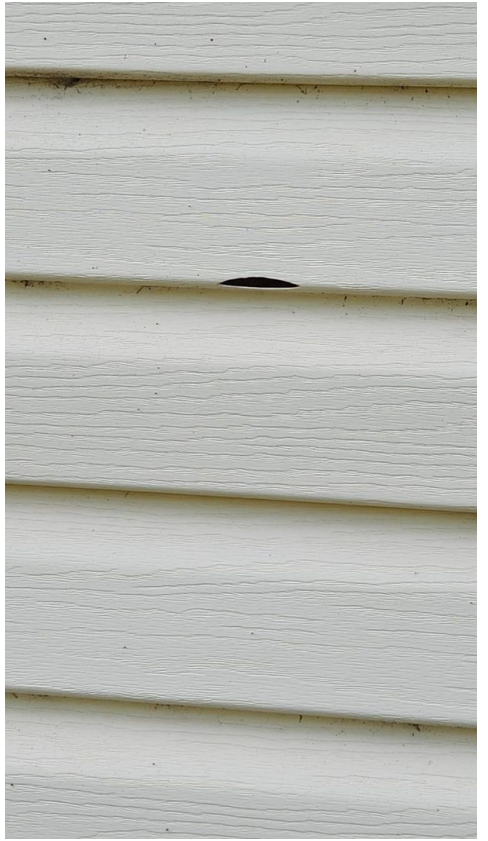
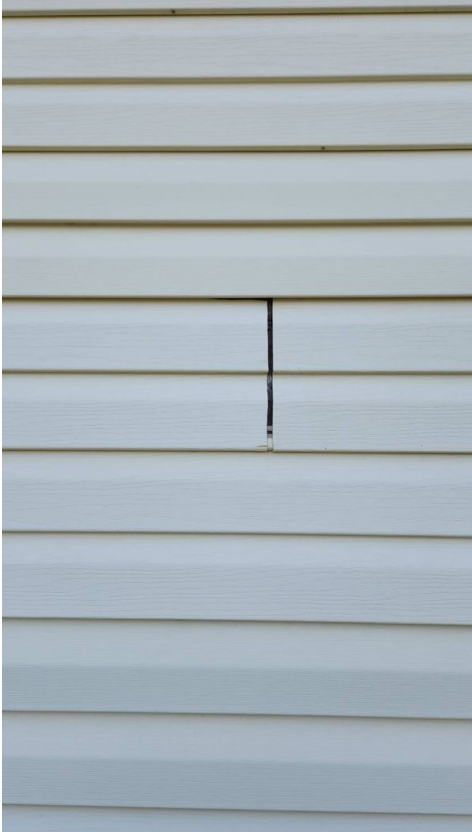
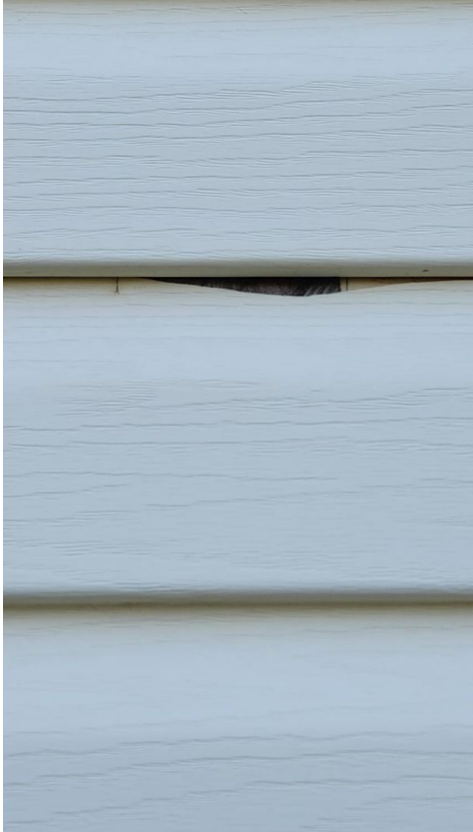
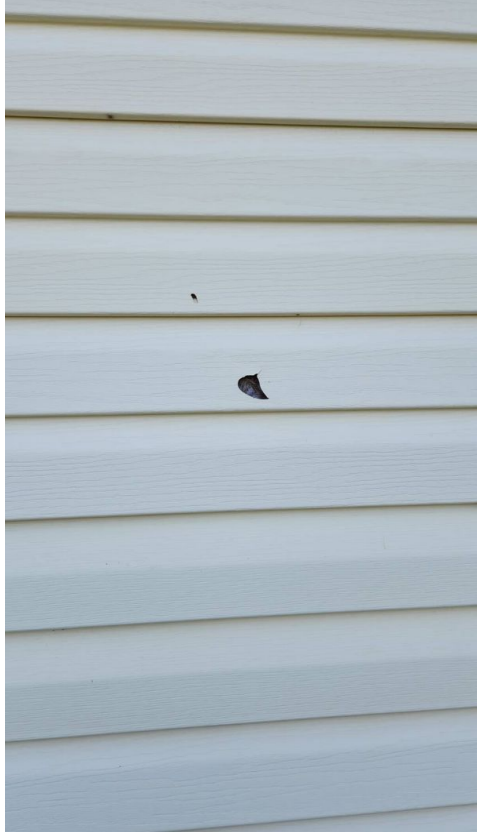
3.3.1 Wall-Covering, Flashing & Trim

DAMAGED WALL-COVERING MATERIAL

Marginal Defects

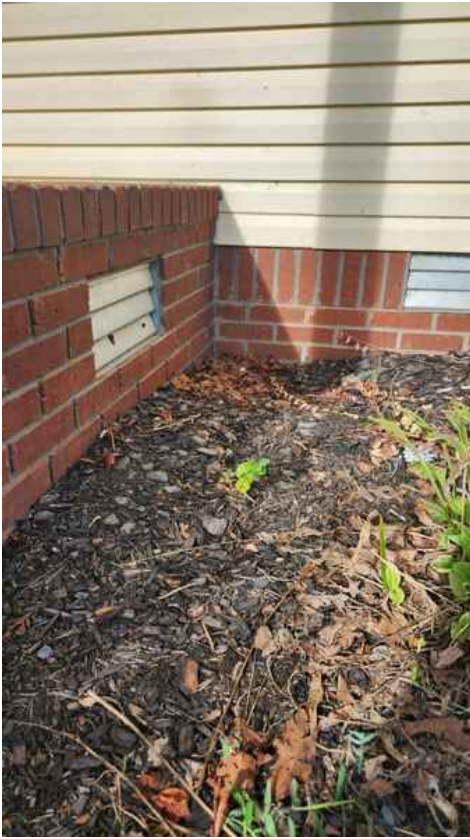
Front by porch

3.4.1 Vegetation, Surface Drainage, Retaining Walls & Grading

Contact a qualified landscaping contractor

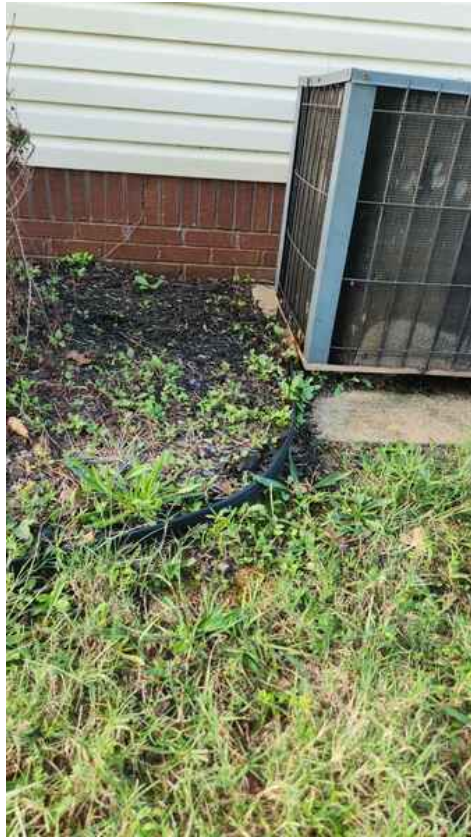
Water runs toward AC unit. Could run under house.

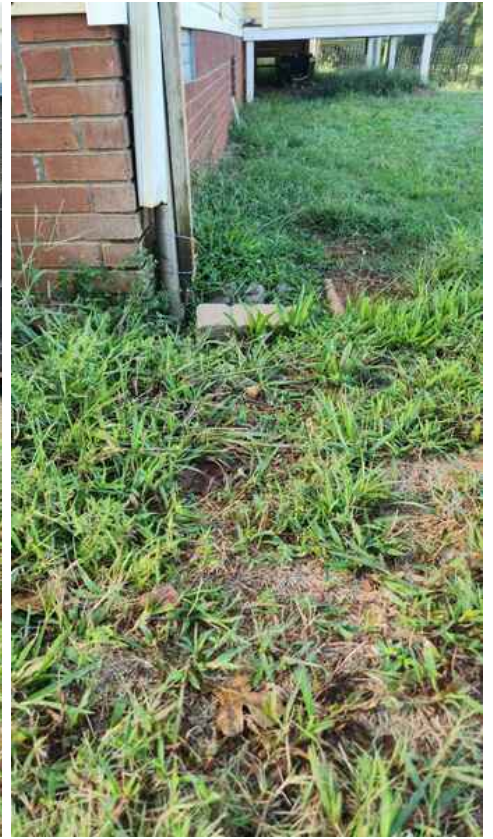
Back corner hole at downspout and slopes to crawlspace access.

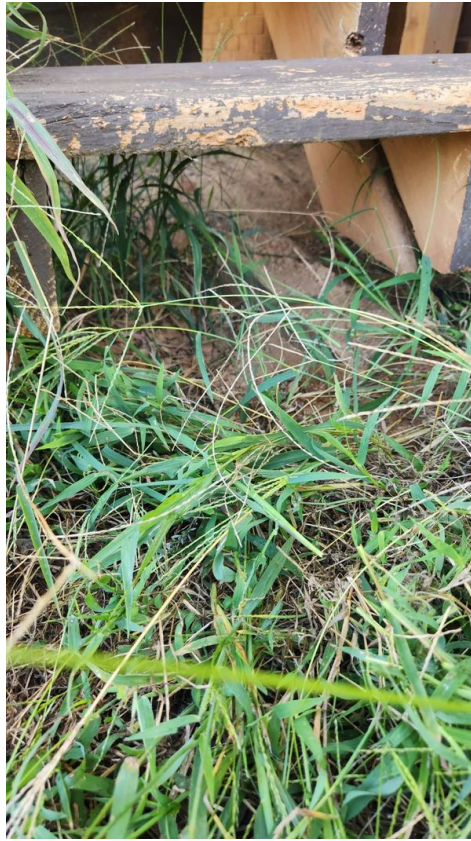
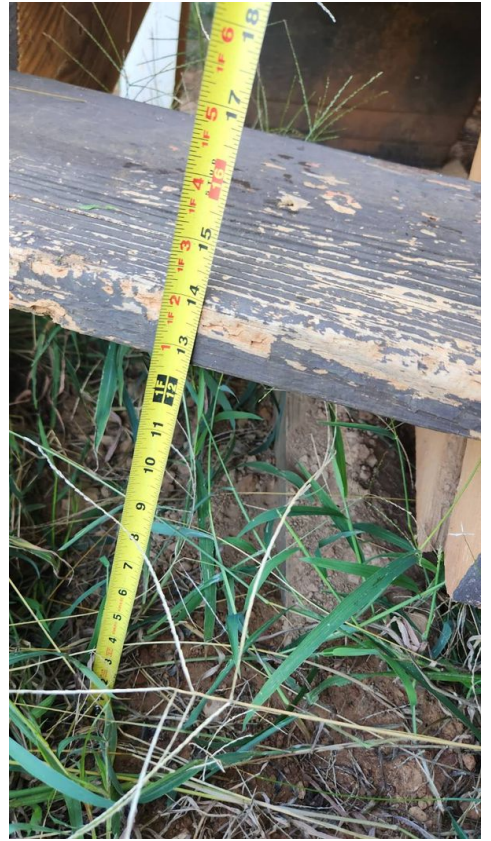
3.6.2 Stairs, Steps, Stoops, Stairways & Ramps

RISER HEIGHT TOO TALL (GREATER THAN 7 3/4")

Recommendation

Contact a qualified professional.

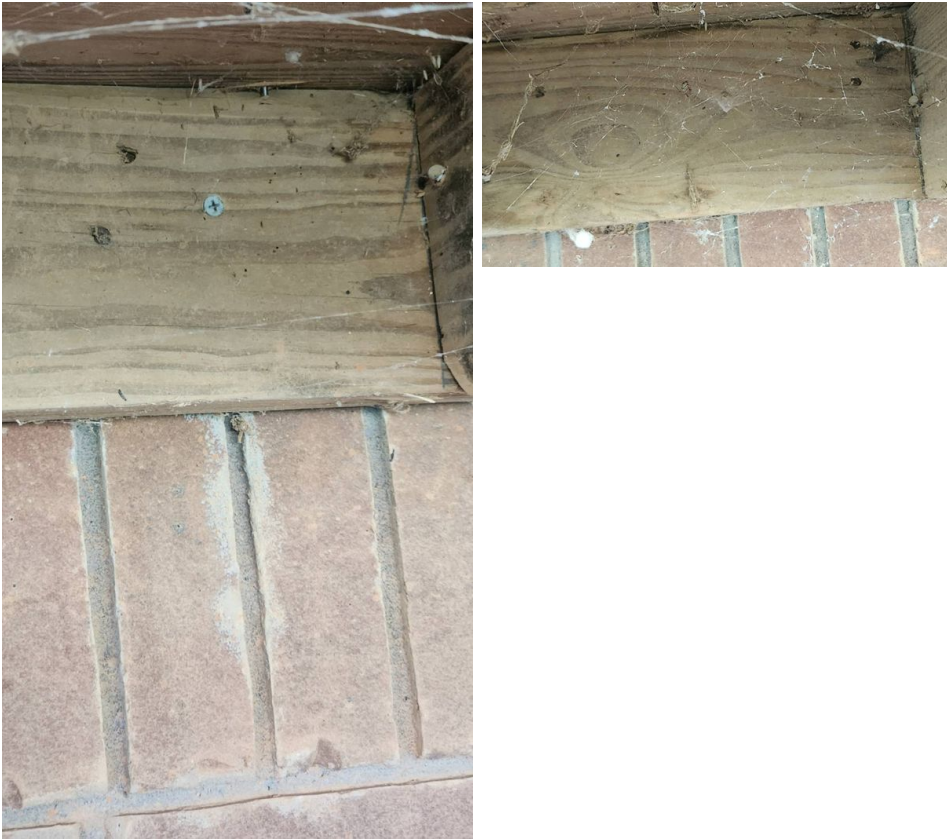
3.8.1 Porches, Patios, Decks & Balconies

DECK - FASTENER DEFECT

Marginal Defects

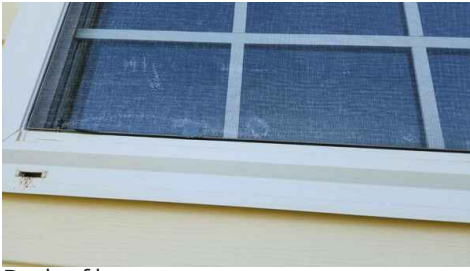
Back of house

3.10.1 Windows

DAMAGED WINDOW SCREEN

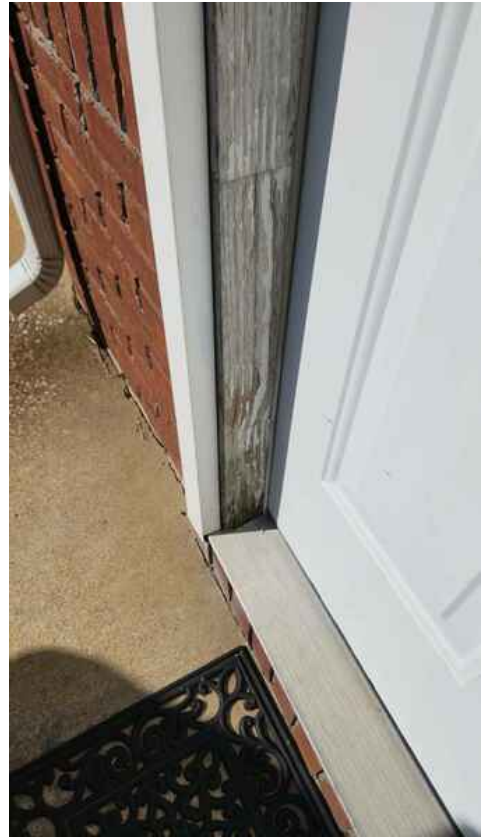
Garage

3.11.1 Exterior Doors

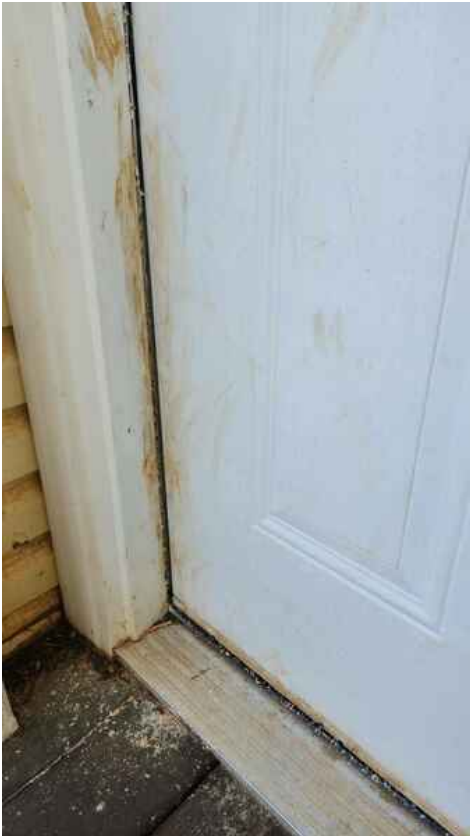
Back door

3.11.2 Exterior Doors
DOOR TREAD DEFECT

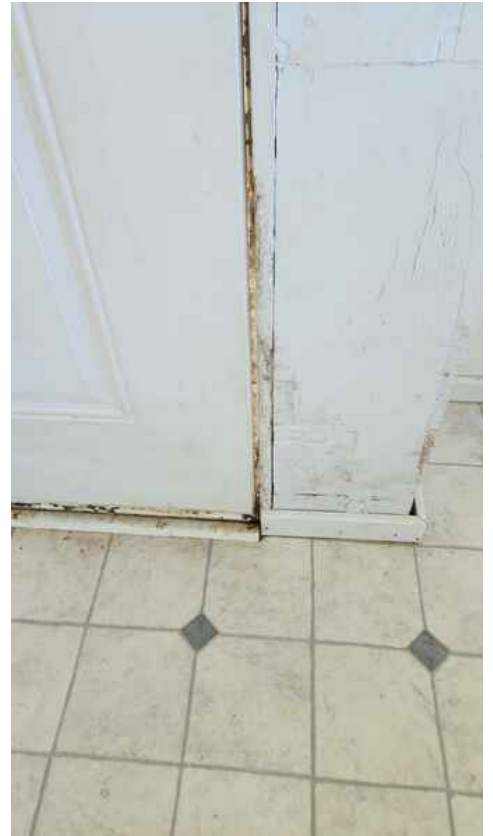
Back Door

3.11.4 Exterior Doors

Contact a qualified handyman.

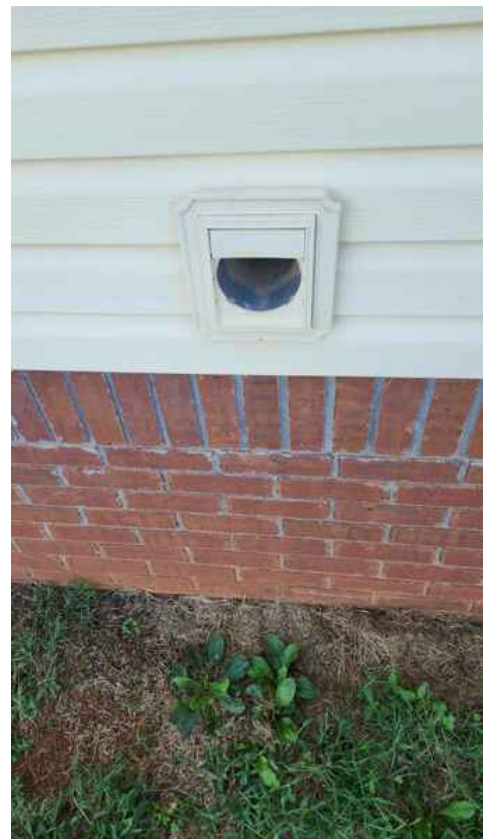
Back of House

3.12.1 Dryer Exhaust Hoods

Contact a handyman or DIY project

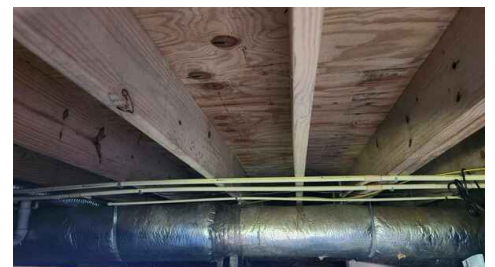
4.2.1 Insulation in Crawlspace

I observed indications of the general absence of insulation in the unfinished crawlspace area.

Contact a qualified insulation contractor.

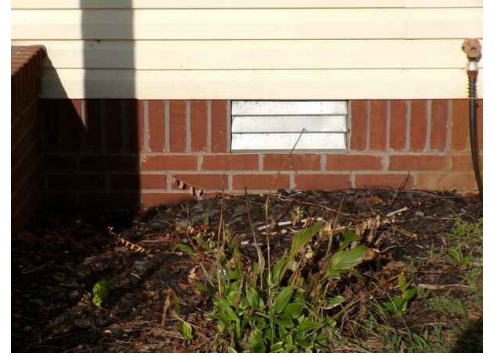
4.3.1 Ventilation in Crawlspace

CRAWLSPACE VENTILATION CLOSED

Crawlspace vents should be opened during warm weather to ventilate moisture from crawlspace. Recommend opening vents at this time.

Recommended DIY Project

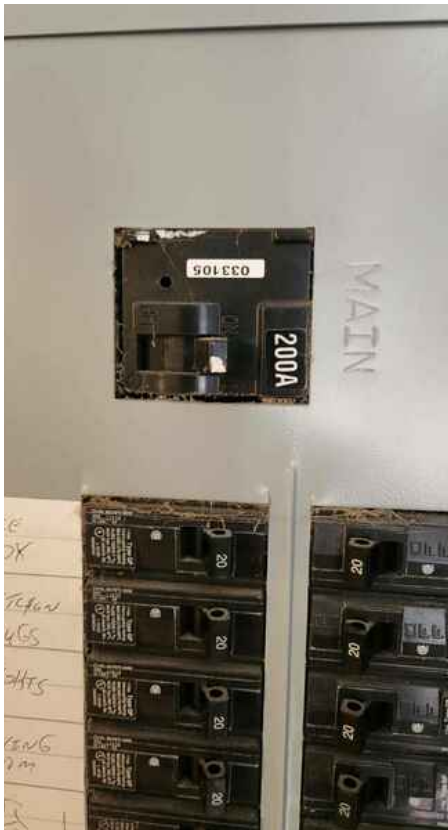
Main Service Disconnect: Inspected Main Service Disconnect

The main electrical service disconnect known as the Main Over Current Protection Device was inspected, looking for any deficiencies or damage, as well as it's location. This is the means of shutting off all of the power that is entering the home.

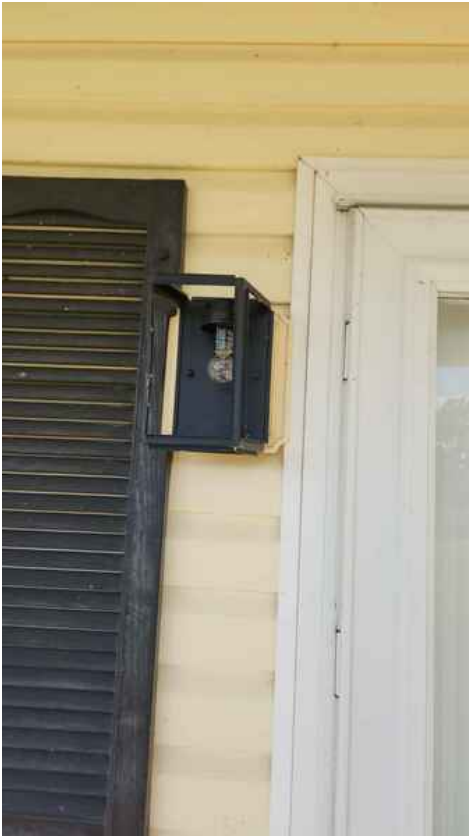
Front porch

LIGHT FIXTURE DAMAGED

I observed damage at one or more light fixtures. Recommend electrician or handyman repair or replace as needed.

Contact a qualified professional.

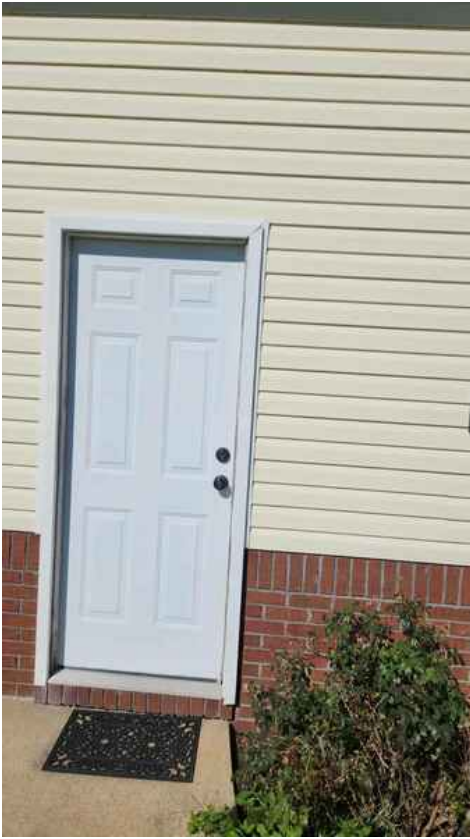
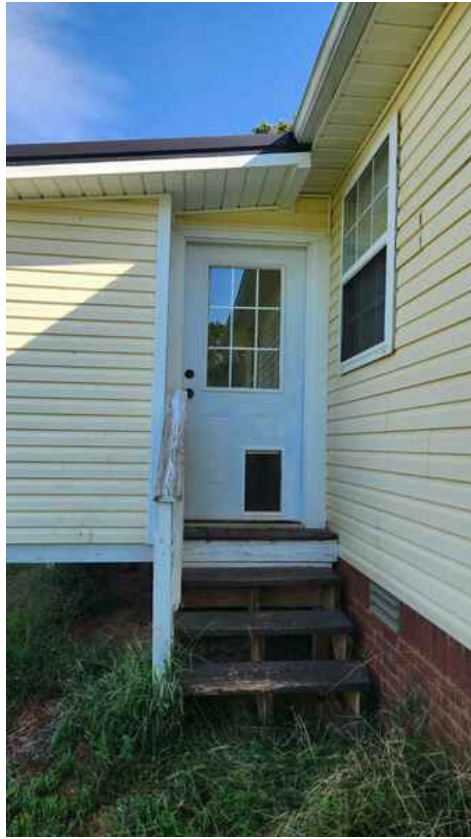
5.11.2 Switches, Fixtures & Receptacles

EGRESS LIGHTING MISSING

There was no egress lighting next to an exterior door. Current standards require a light by each exterior door for safety. Recommend an electrician evaluate and install as needed.

Contact a qualified electrical contractor.

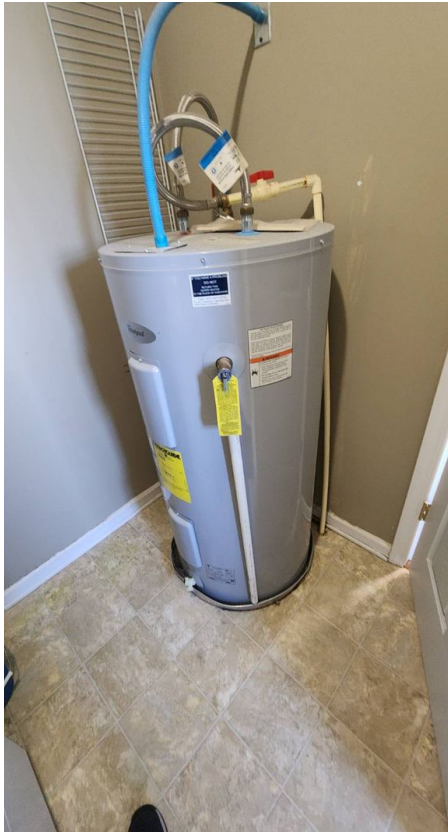
Hot Water Source: Inspected Hot Water Source

The water heater was inspected by looking at the overall condition of the unit, its power source, the water pipes, etc. and that it produced heated water at the time of inspection. No reportable deficiencies were visibly present with the unit unless noted in this report.

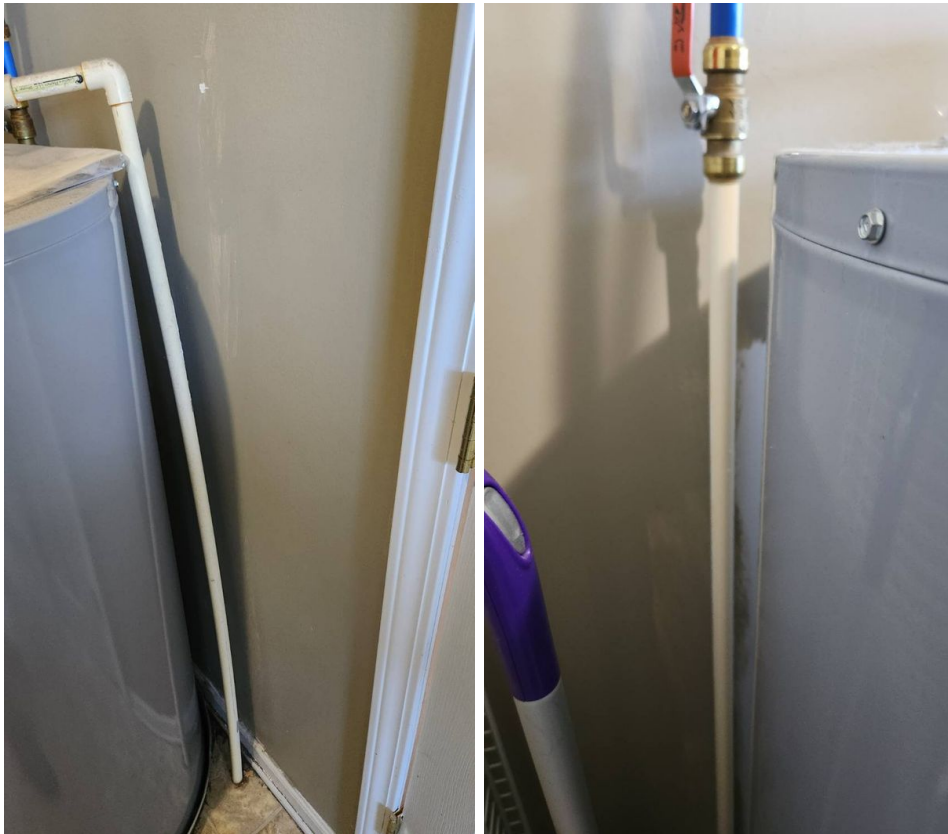
I observed plumbing that was not properly strapped. Recommend handyman or plumber evaluate and properly strap.

Contact a qualified professional.

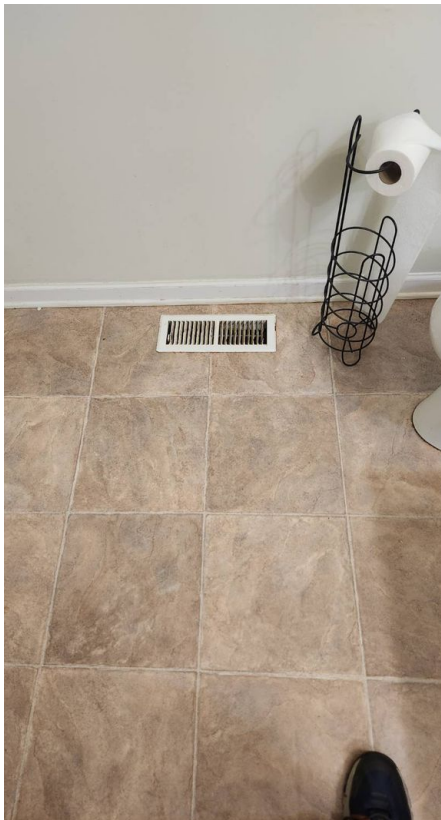
Heat Source in Bathroom: Heat Source in Bathroom Was Inspected

I inspected the heat source in the bathroom (register/baseboard).

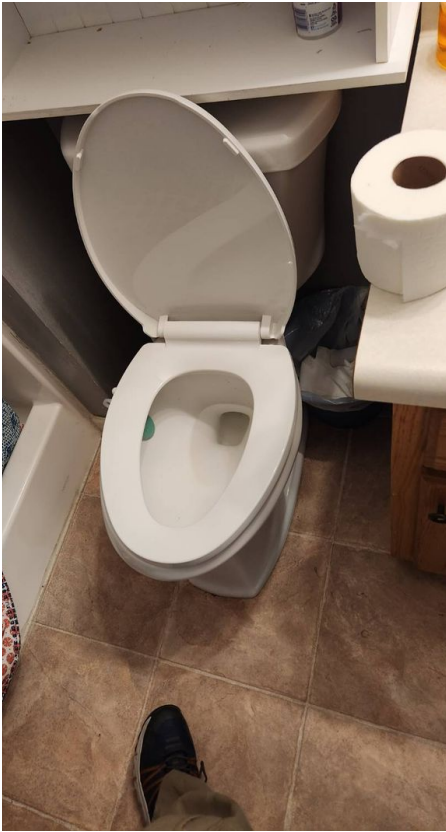
Bathroom Toilets: Toilets Inspected

The toilets were inspected by flushing them to ensure adequate flushing and to determine that no leaks were present at the water supply line or tank location. No deficiencies were observed unless otherwise noted in this inspection.

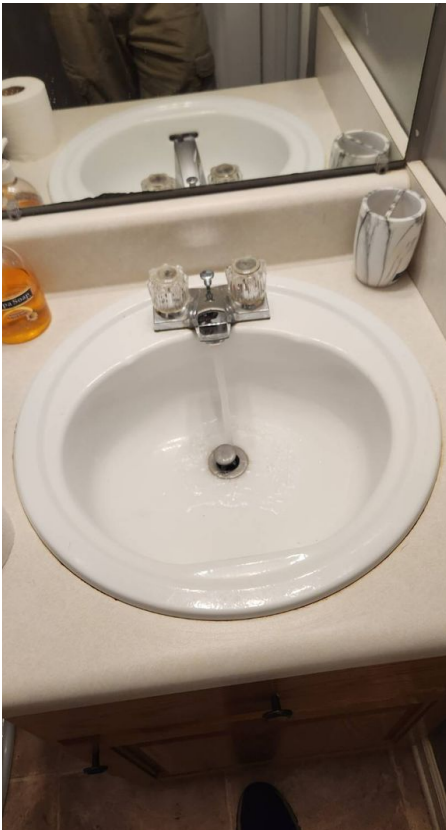
**Sinks, Tubs & Showers: Ran Water at Sinks, Tubs & Showers**

I ran water at all bathroom sinks, bathtubs, and showers. I inspected for deficiencies in the water supply by viewing the functional flow in two fixtures operated simultaneously.

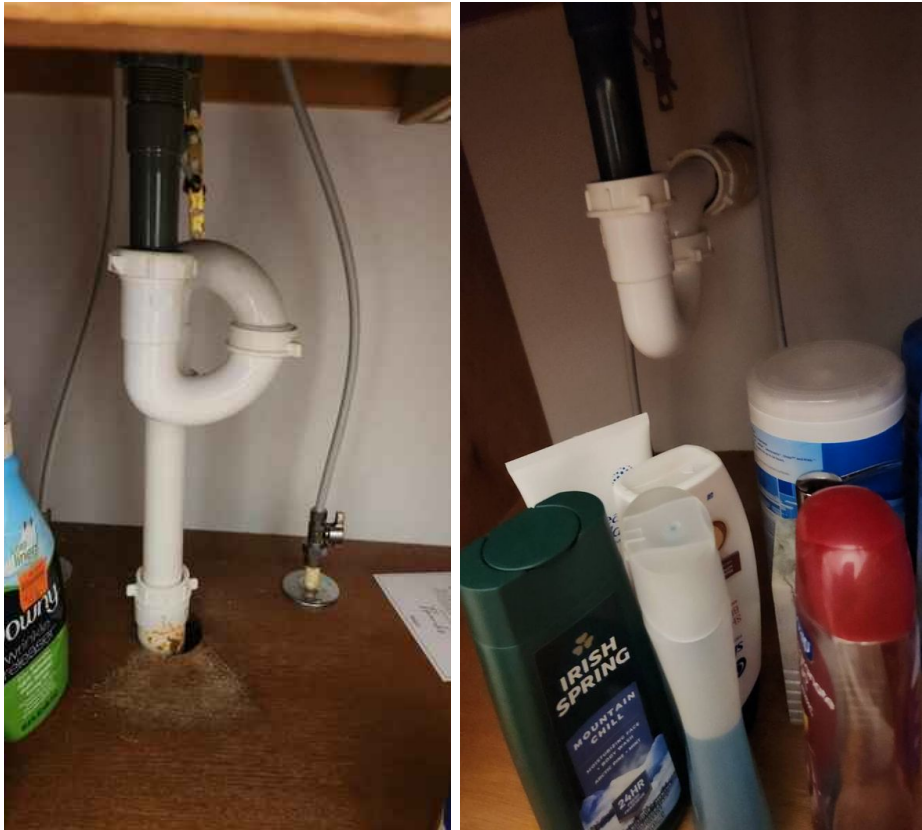
Sinks, Tubs & Showers: Under Sink Plumbing Information

The visible portions of the sink plumbing was inspected by running water through the drain pipe for over one minute and looking for leaks from the drain pipe/trap assembly, water supply lines, and areas underneath the sink area. Other significant defects are looked for within the plumbing. No reportable conditions were observed unless otherwise noted in this report.

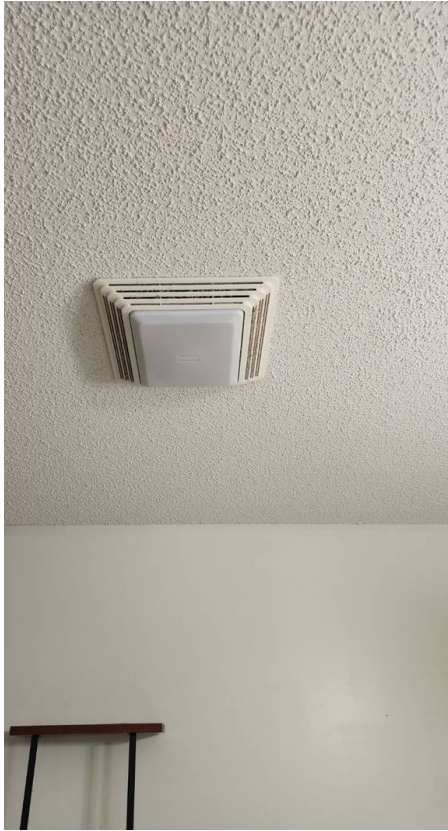
Bathroom Exhaust Fan : Inspected Bath Exhaust Ventilation

Bathroom ventilation is reported on by its source: windows or ventilation fans are acceptable forms of ventilation for bathrooms containing a tub or shower. If fans are present they will be tested by operating the switch and listening for proper air flow. Although windows in a bathroom can substitute for a fan, a fan is still recommended due to not utilizing windows in cold winter months. No reportable conditions were observed unless otherwise noted in this report.

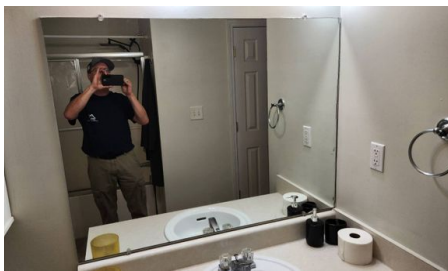
Mirrors: Mirror Information

The bathroom mirror(s) were inspected looking at their attachment to the wall and for any damage. No reportable conditions were observed unless otherwise noted in this report.

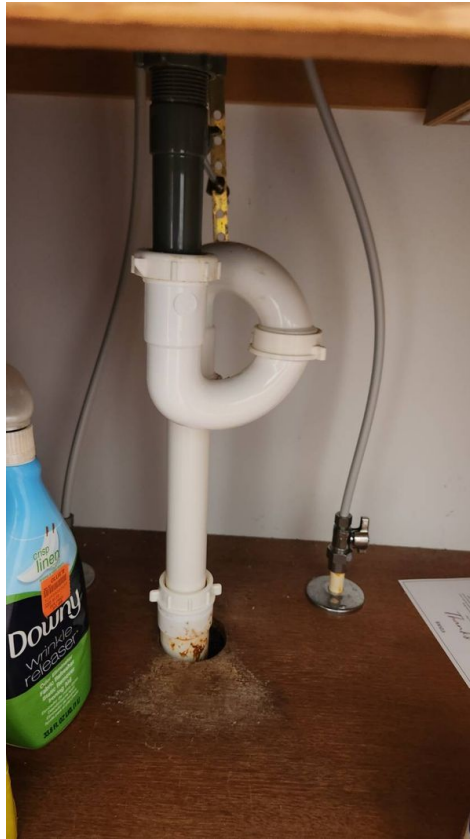
8.2.1 Sinks, Tubs & Showers

DEFECT AT S-TRAP

I observed indications of a defect at the sink drain trap. It is an S-trap, which are not permitted. It should be a P-trap. Please see illustration for details.

Recommended DIY Project

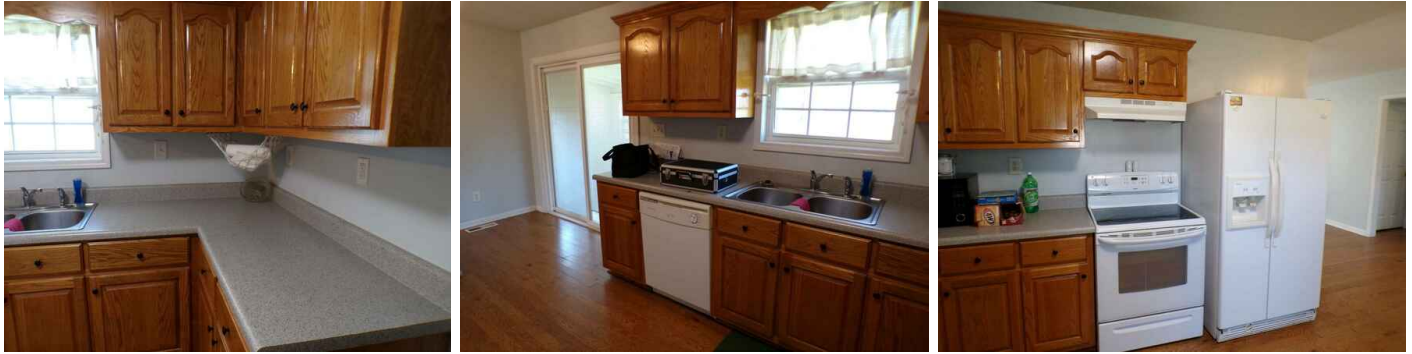
Cabinetry/Countertops: Cabinetry/Countertops Were Inspected

The kitchen cabinetry, bathroom cabinetry and any other cabinets and countertops were inspected looking for significant damage and by testing a representative number of doors and drawers evaluating their operation. No reportable conditions were present at the time of inspection unless otherwise noted in this report.

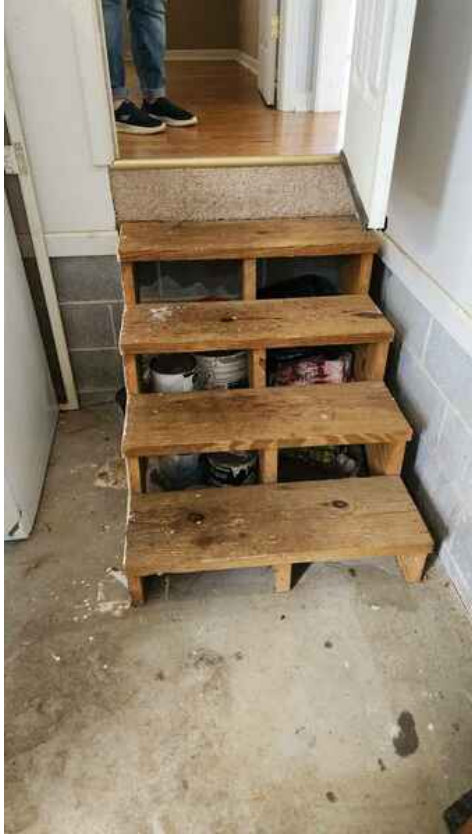
Garage

MISSING HANDRAIL

I observed a missing handrail.

There is more than one step here, and I recommend installing a handrail for safety.

Contact a qualified professional.

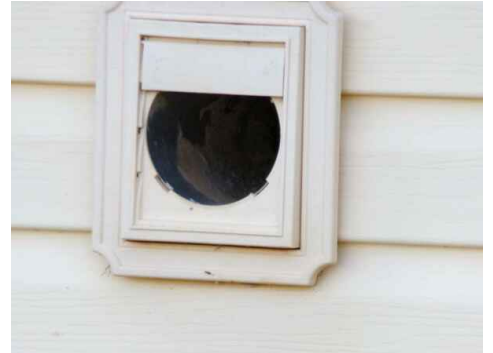
DEFECT AT DRYER EXHAUST PIPE

Contact a qualified appliance repair professional.

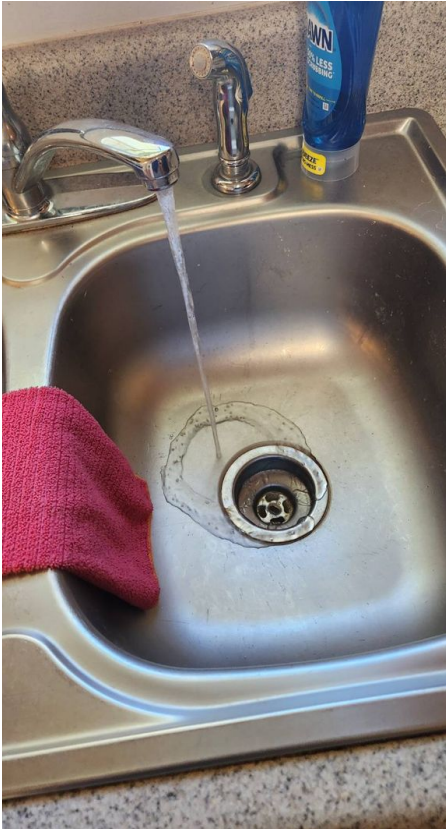
Kitchen Sink: Ran Water at Kitchen Sink

I ran water at the kitchen sink inspecting for deficiencies in water supply and drainage looking for active leaks and improper installation.

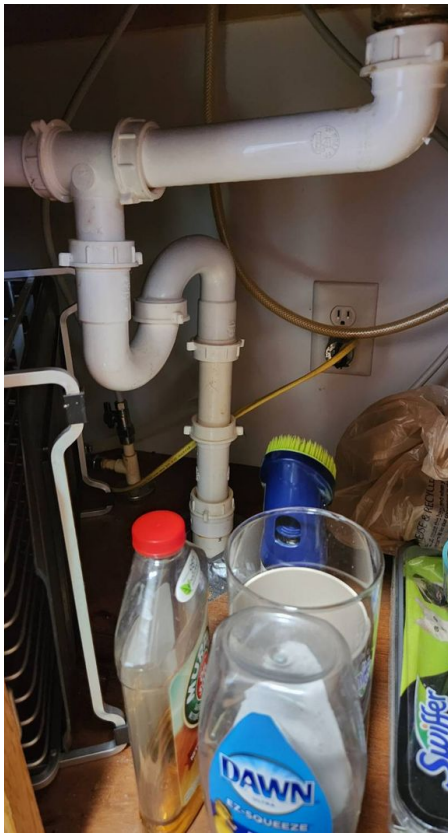
Kitchen Sink: Under Sink Plumbing Information

The supply and drain pipes were inspected looking for leaks, improper installation and other deficiencies. No reportable conditions were observed unless otherwise noted in this report.

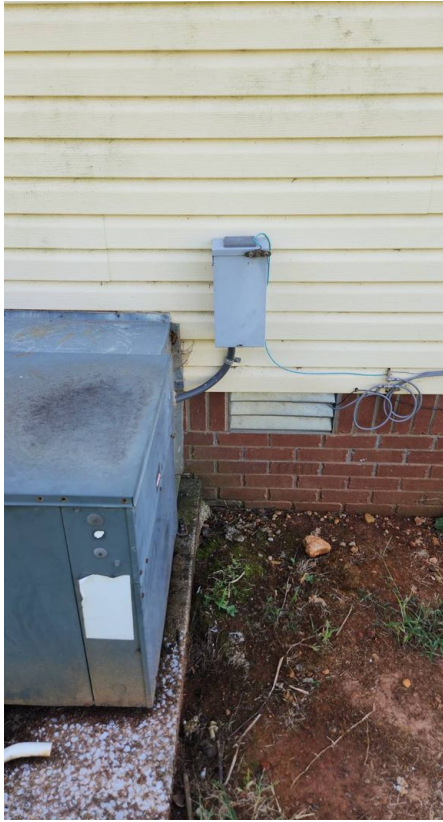
**Cooling System Information:
Service Disconnect Inspected**

I observed a service disconnect within sight of the cooling system.

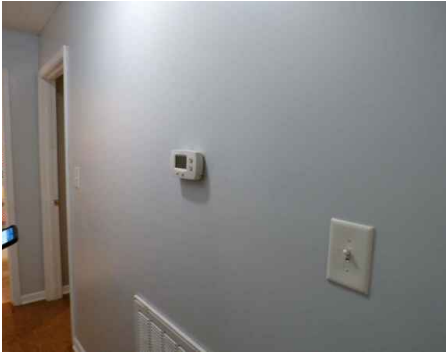
Thermostat and Normal Operating Controls: Thermostat inspected

The thermostat was inspected for proper operation. No defects observed unless otherwise noted in this inspection.

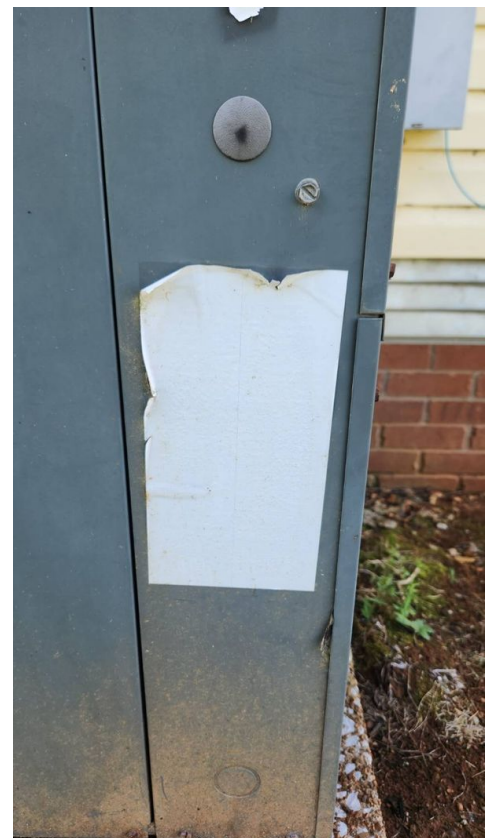
COULD NOT READ LABELS

Observed that the labels were too worn to be able to read information

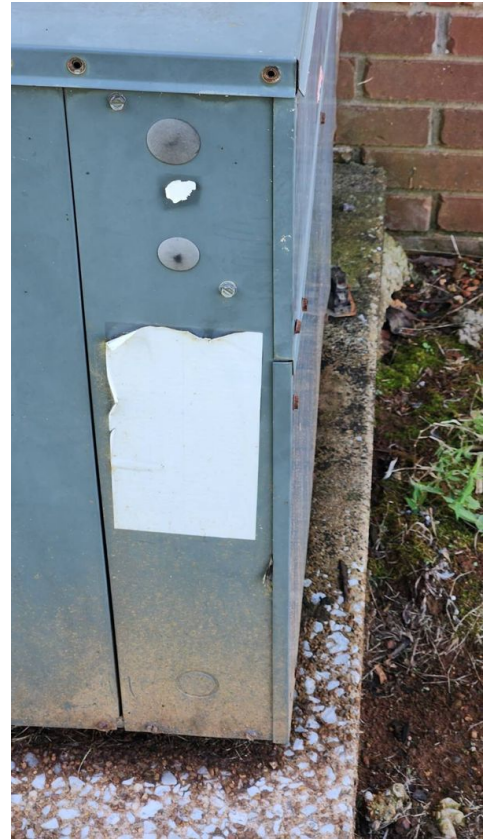
LABEL WORN OUT

I observed that the manufacturing label on the system was worn out and illegible. This is an indication of old age.
