KEVIN'S INSPECTIONS

1234 Main Street
Columbia, TN 38401

Buyer Name
01/30/2025 9:00AM

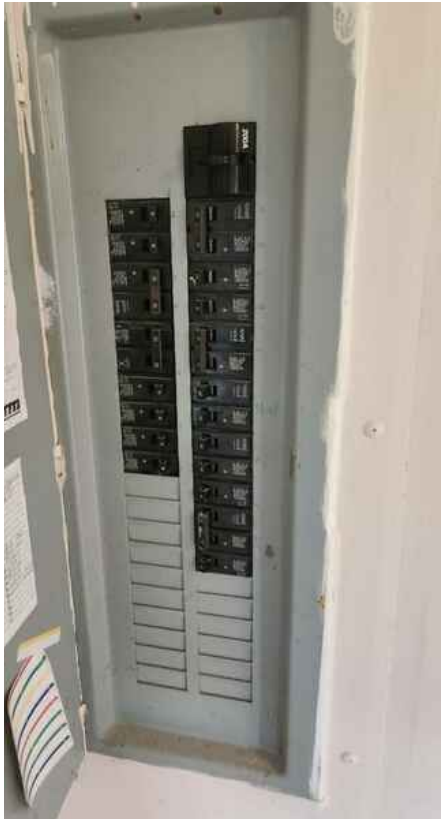
Electric Shut Off: Electric Shut Off

Main breaker in breaker panel

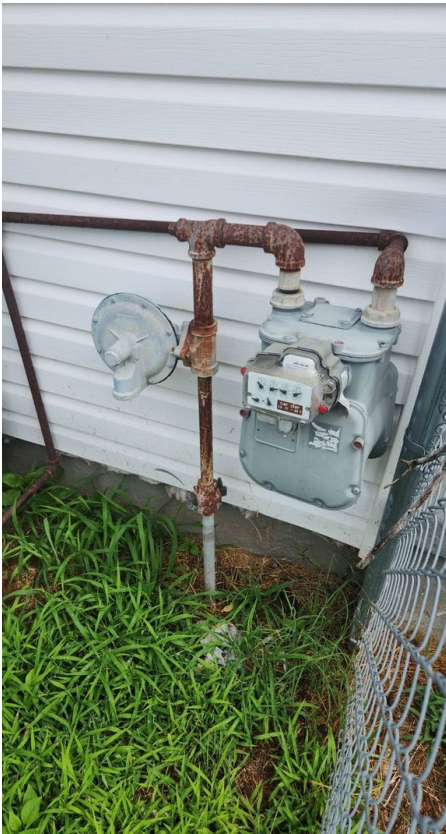
Gas Shut Off: Main Gas Shut-off Location

Gas Meter

The pictured gas shut-off valve will shut off the gas supply to home in case of an emergency or for servicing.

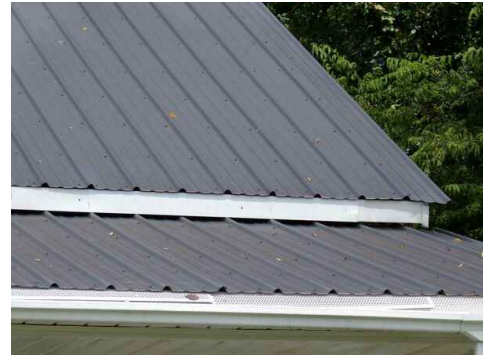
*I did not walk on the roof to prevent damage of the metal roof and due to the dipping and bending noticed from the ground and ladder.

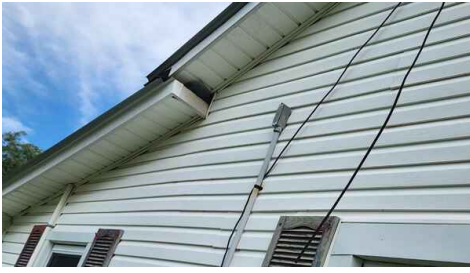
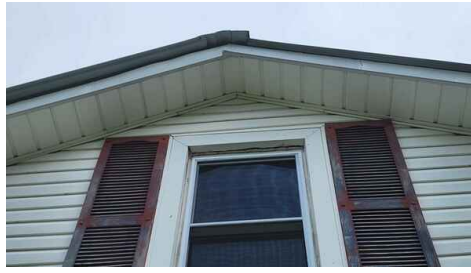
INSTALLATION DEFECT AT ROOF COVERING

Major Defect

I observed indications of improperly installed roof-covering materials. This is not according to best practices or common standards. Defect. Prone to water intrusion and roof leaks. Further evaluation and correction by a roofer is recommended.

*I observed metal roofing hanging too far off the gable ends and no gable trim installed.

Contact a qualified roofing professional.

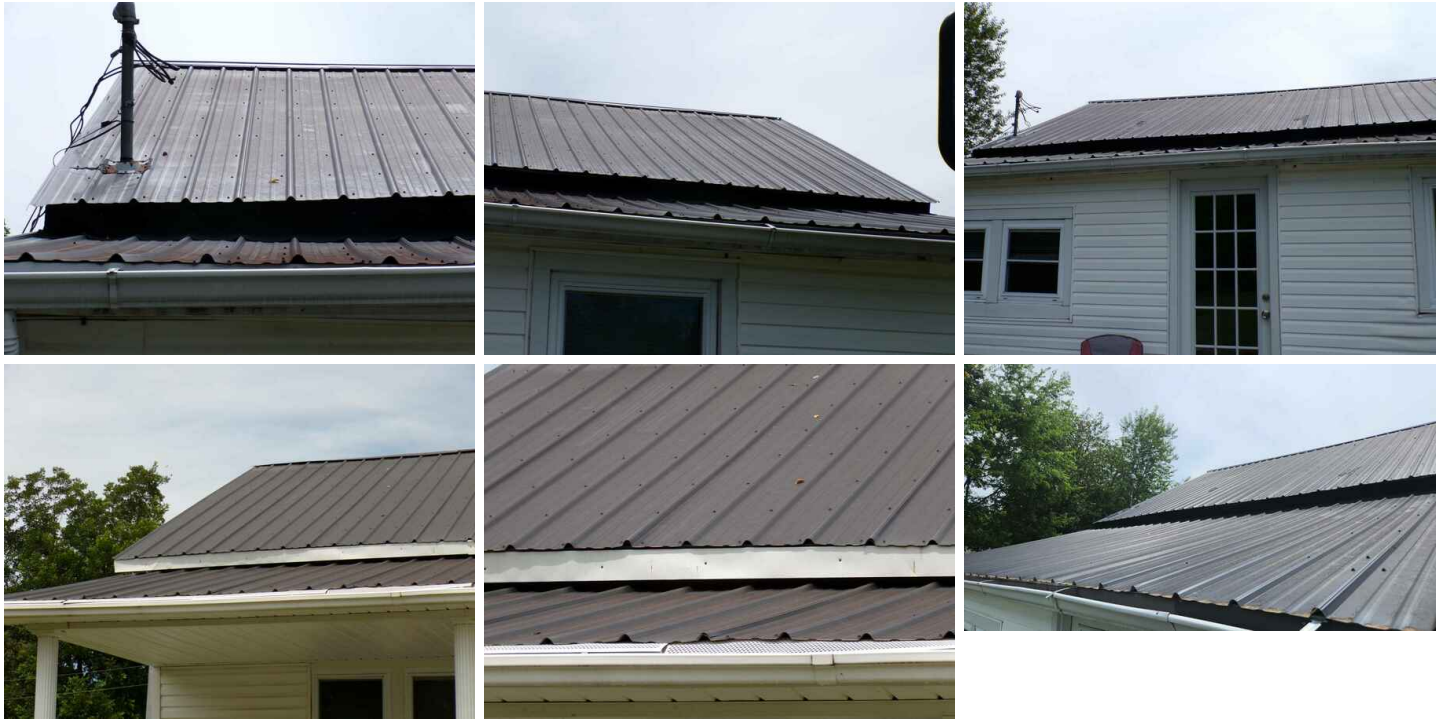
3.1.2 Roof Covering

ROOF STRUCTURE SAGGING

Areas of the roof were observed to be sagging and/or dipping. Recommend a qualified professional/roofer to evaluate and make appropriate repairs as needed.

Contact a qualified professional.

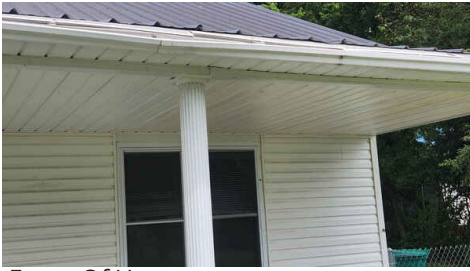
,Front Of House

GUTTER FASTENING DEFECT

Minor Defect

I observed indications of a defect at the gutter fastening.

Contact a qualified handyman.

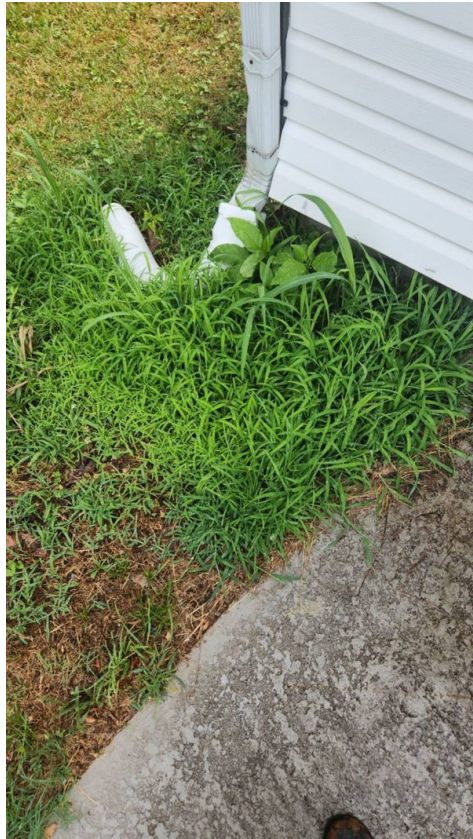
One or more downspouts drain too close to the home's foundation. This can result in excessive moisture in the soil at the foundation, which can lead to foundation/structural movement. Recommend a qualified contractor adjust downspout extensions to drain at least 6 feet from the foundation. A handy homeowner should be able to do this project.

Contact a handyman or DIY project

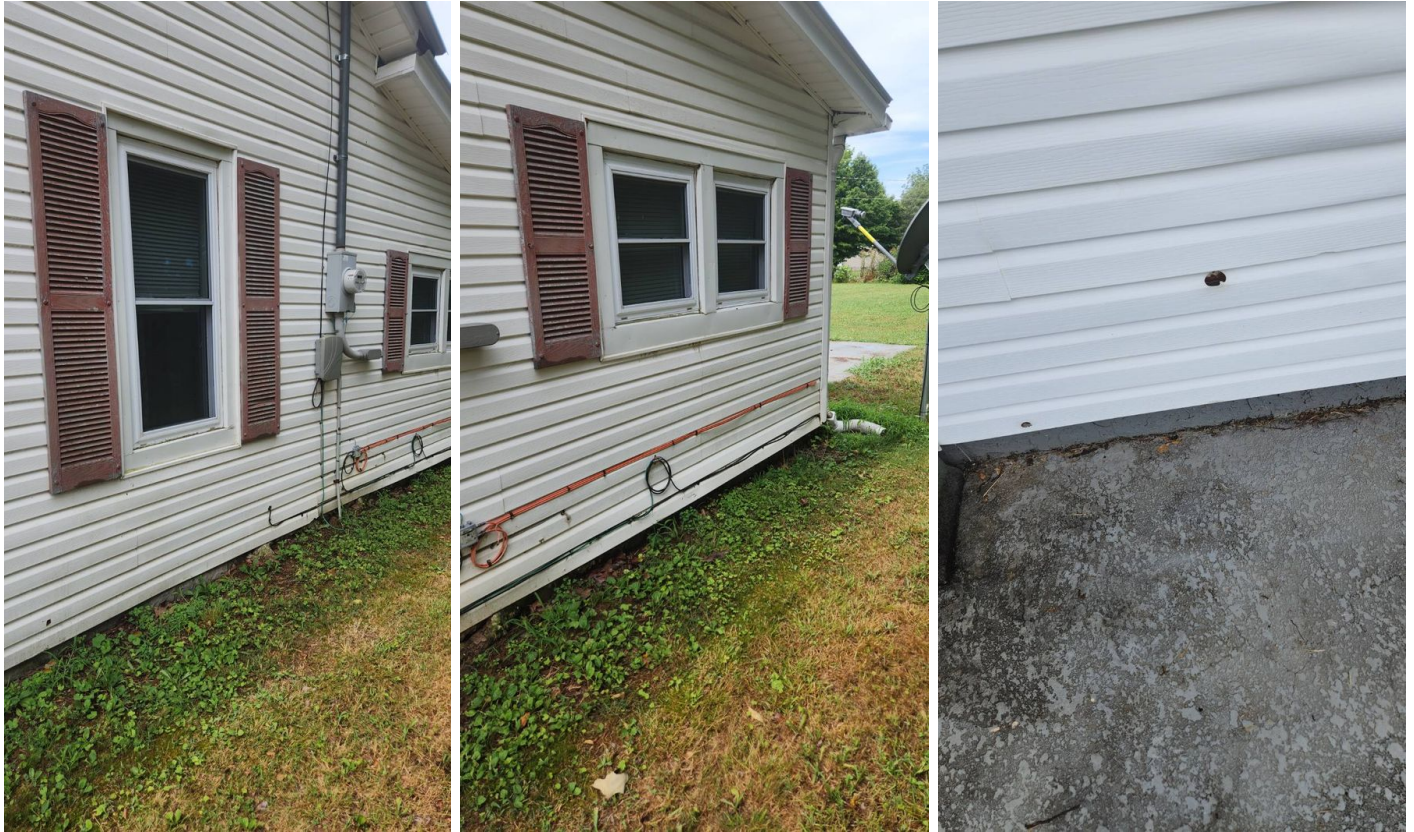
Wall-Covering, Flashing & Trim: Worn Out Areas of Exterior Wall-Covering

I observed indications of worn out areas, delayed maintenance, or aging.

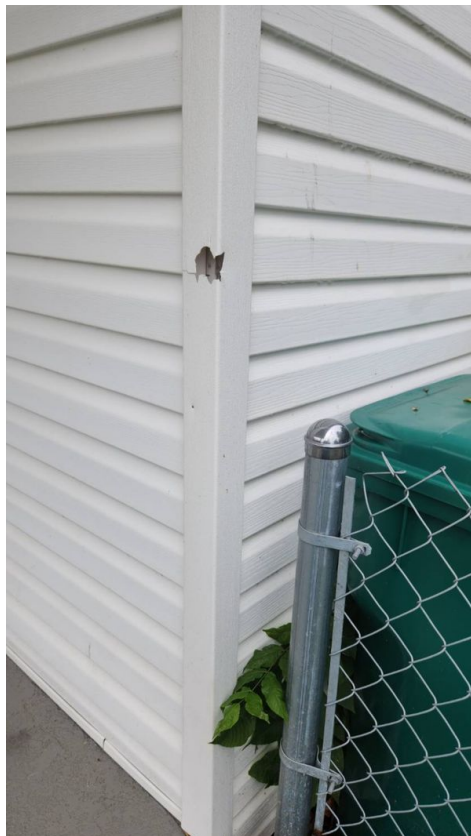
DAMAGED WALL-COVERING MATERIAL

I observed indications of a defect at the exterior wall-covering material.

Correction and further evaluation is recommended.

Contact a qualified siding specialist.

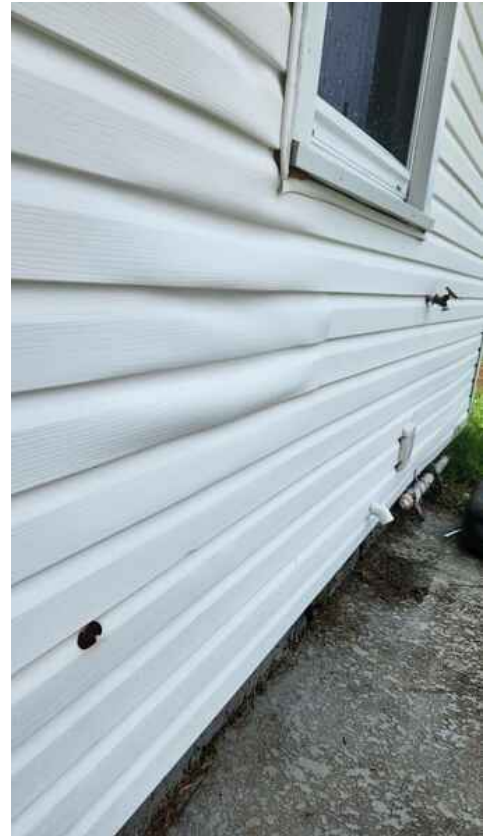
I observed indications of melted vinyl siding. Maybe from a grill that contacted the vinyl material.

Contact a qualified professional.

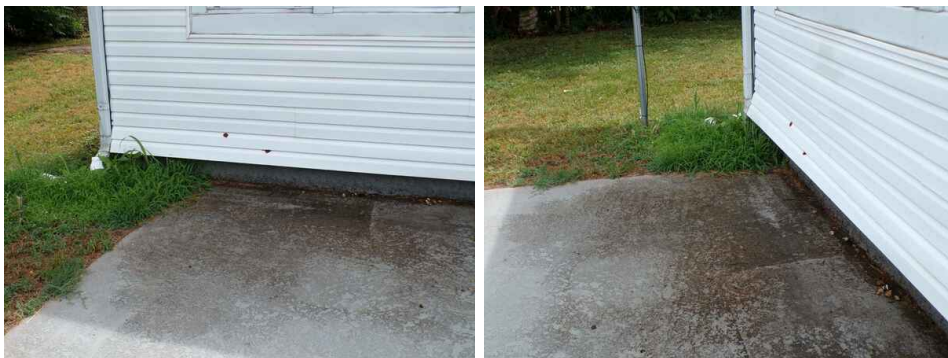
4.3.4 Wall-Covering, Flashing & Trim

LOOSE WALL-COVERING MATERIAL

I observed indications of loose areas of the exterior wall-covering material.

Correction and further evaluation is recommended.

Contact a qualified professional.

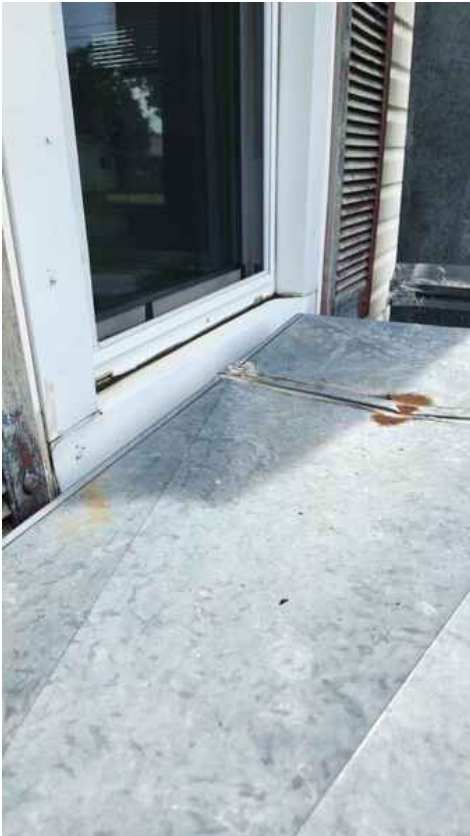
4.3.5 Wall-Covering, Flashing & Trim

There was a problem at the Window flashing at one or more windows. Recommend a window or siding professional evaluate and repair as needed.

Bottom window trim slopes toward window

Contact a qualified professional.

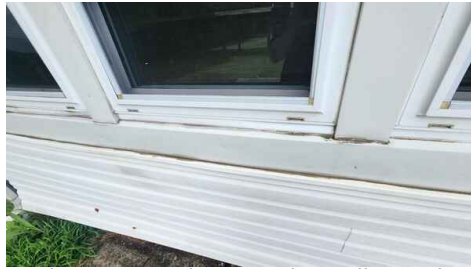
Back patio window needs caulk touch up

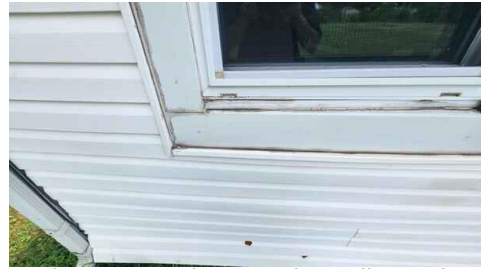
Back patio window needs caulk touch up

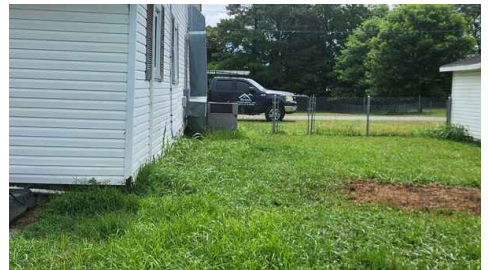
Side of house. Hard to tell with high grass. Slopes toward house

Contact a qualified landscaping contractor

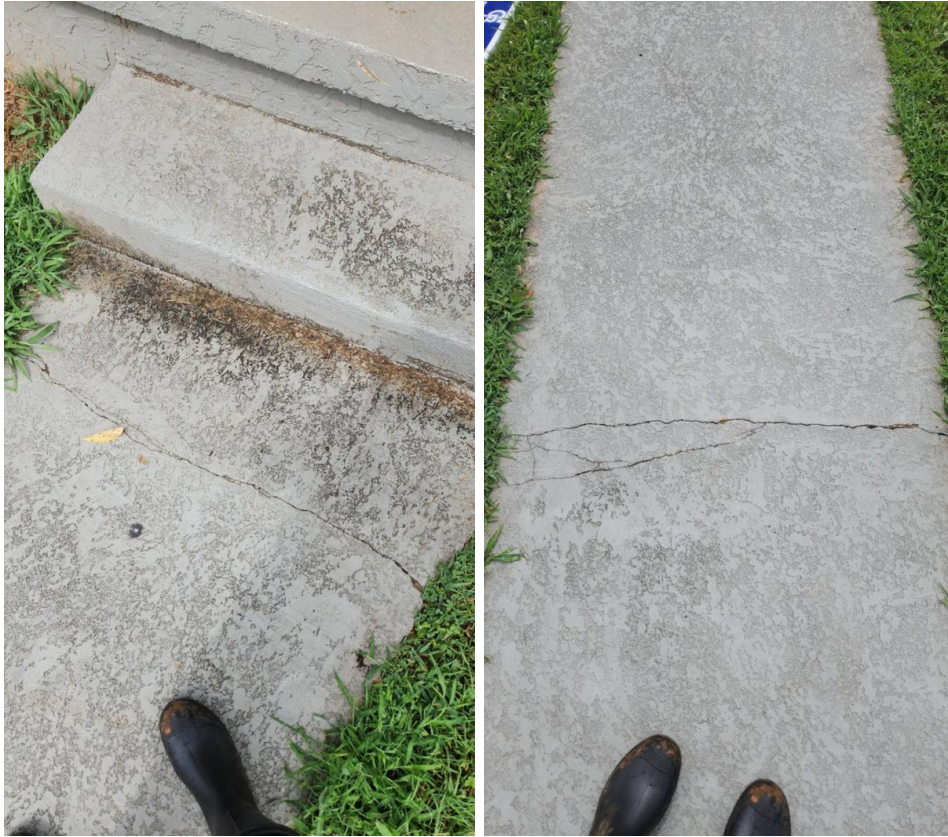
MINOR CRACKING AT WALKWAY

I observed minor cracking and no major damage at the walkway.

Recommend monitoring.

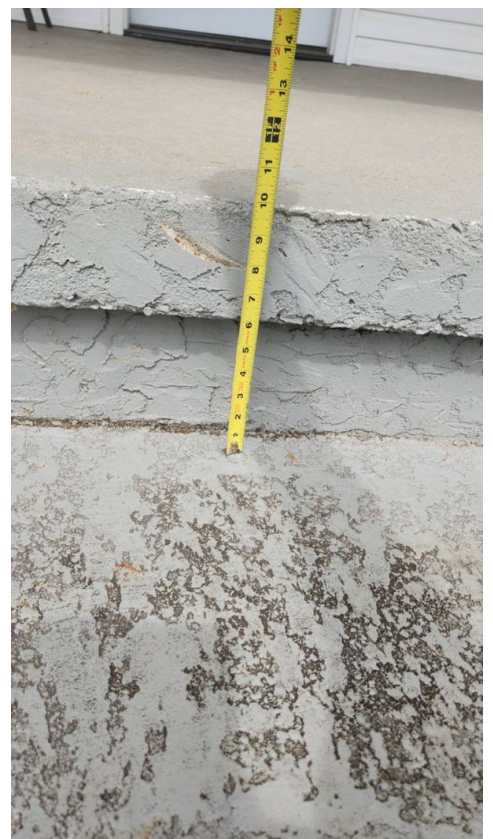
4.7.1 Stairs, Steps, Stoops, Stairways & Ramps

RISER HEIGHT TOO TALL (GREATER THAN 7 3/4")

I observed a defect at the stair riser height.

The riser height maximum is 7 3/4 inches measured vertically between the stair treads. This poses a trip hazard.

Contact a qualified professional.

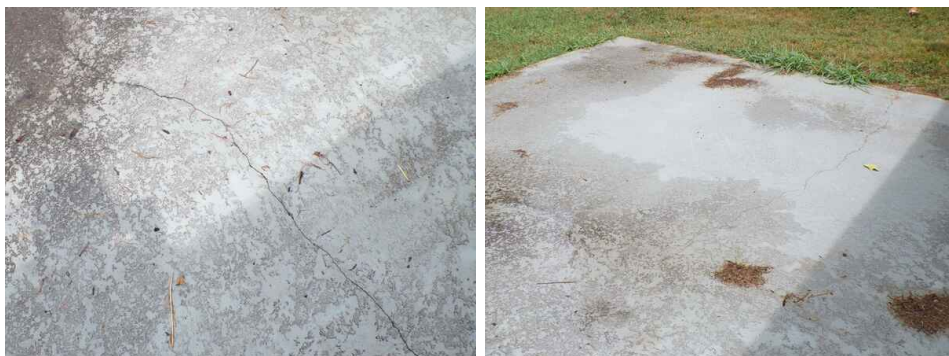
MINOR CRACKING AT PATIO

I observed minor cracking on the patio concrete slab. Recommend monitoring and/or evaluation by a concrete contractor to prevent further damage.

Contact a qualified concrete contractor.

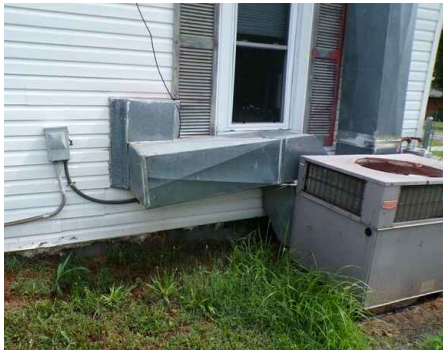
Cooling System Information: Service Disconnect Inspected

I observed a service disconnect within sight of the cooling system.

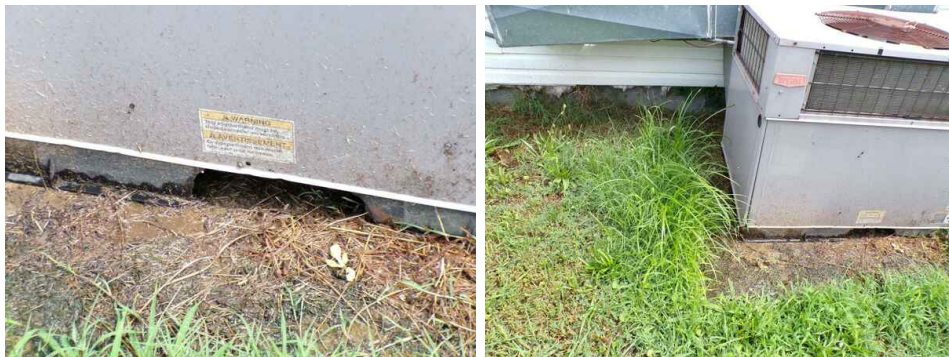
Can't tell where the water is coming out from No condensate pipe

Contact a qualified professional.

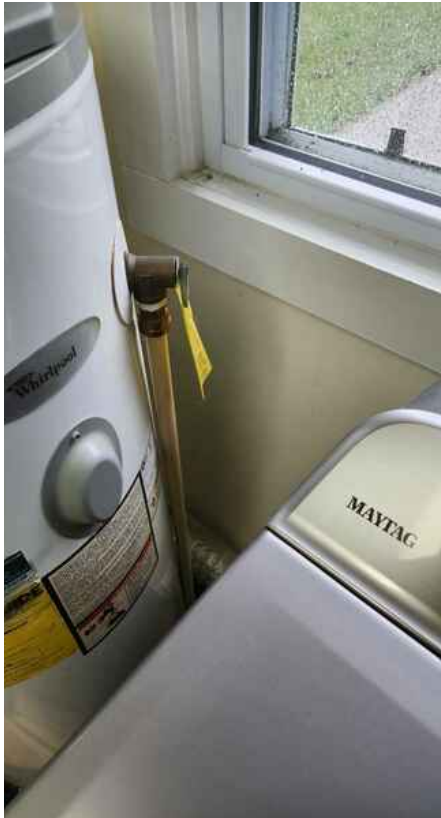
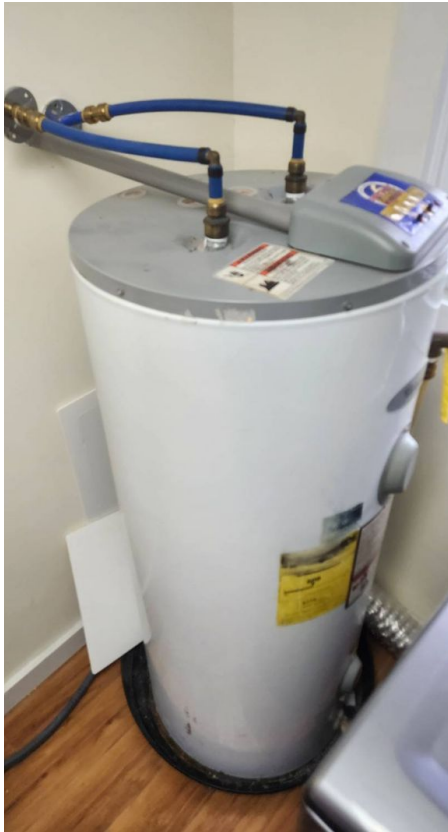
Hot Water Source: Manufacturer
Whirlpool

Hot Water Source: Capacity
40 Gallons

Electric Hot Water Tank

I inspected for the main source of the distributed hot water to the plumbing fixtures (sinks, tubs, showers). I recommend asking the homeowner for details about the hot water equipment and past performance.

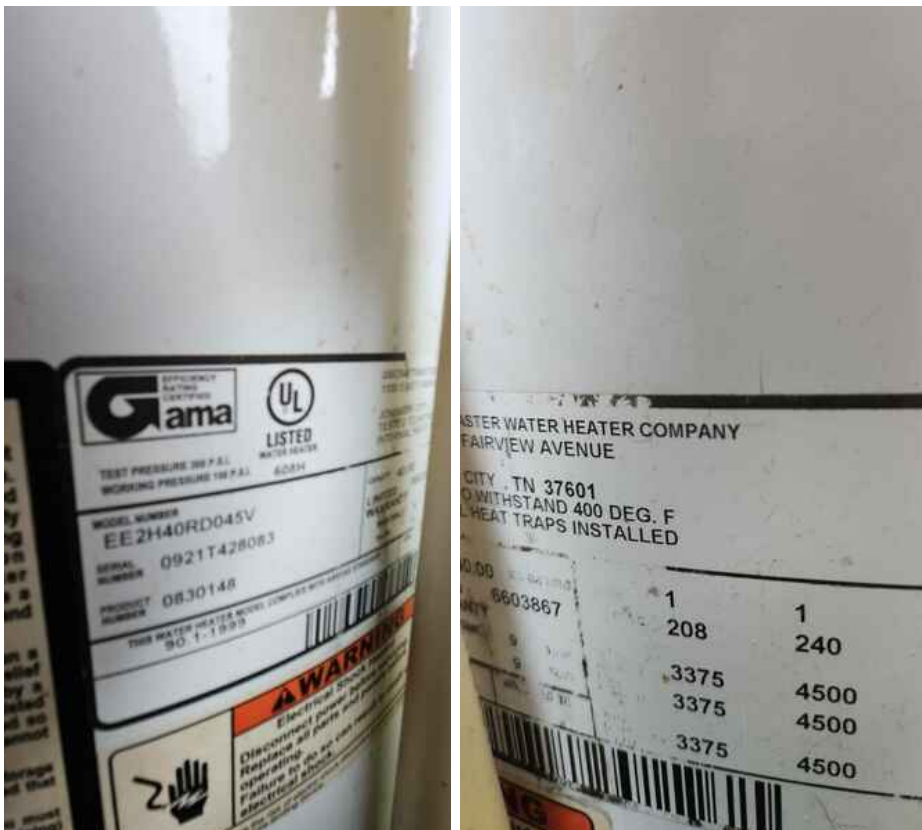
Hot Water Source: Inspected Hot Water Source

I inspected the hot water source and equipment according to the [Home Inspection Standards of Practice](#).

Not sure, Looks like a 2009

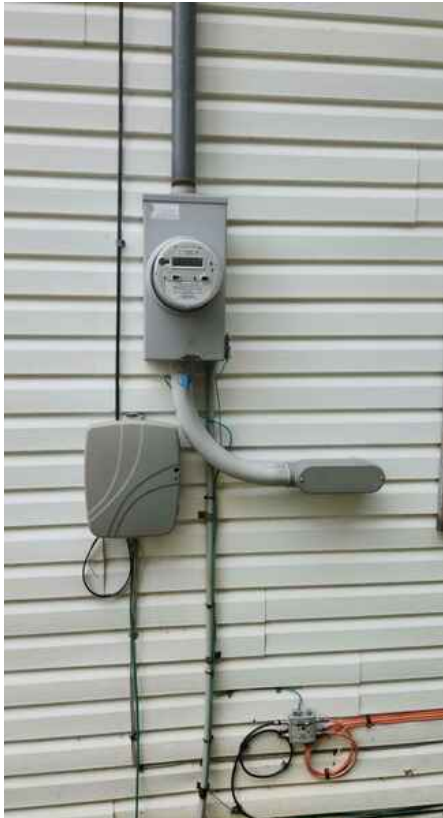
Electric Meter & Base: Inspected the Electric Meter & Base

I inspected the electrical electric meter and base.

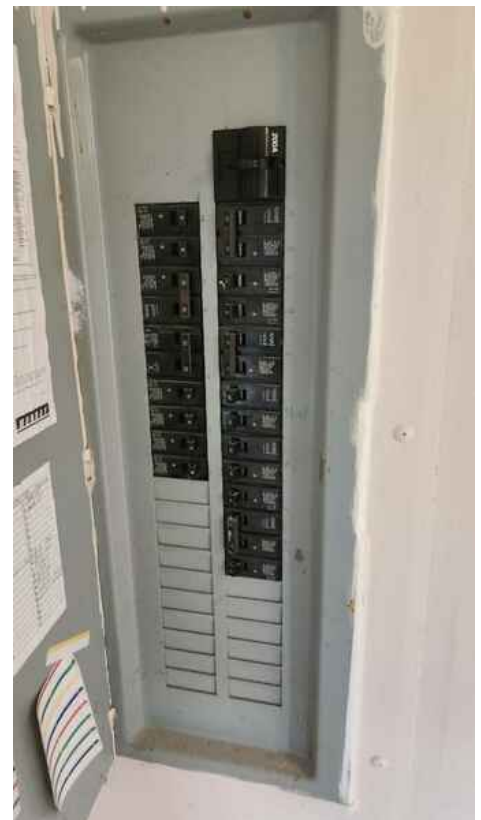
Main Service Disconnect: Inspected Main Service Disconnect

I inspected the electrical main service disconnect.

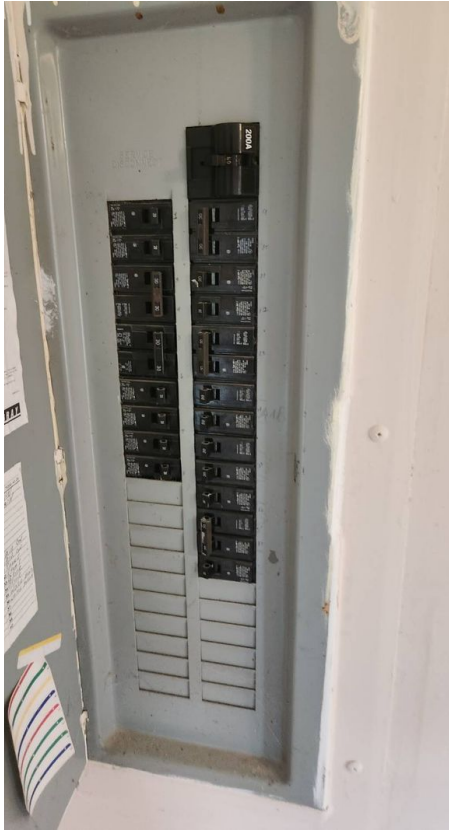
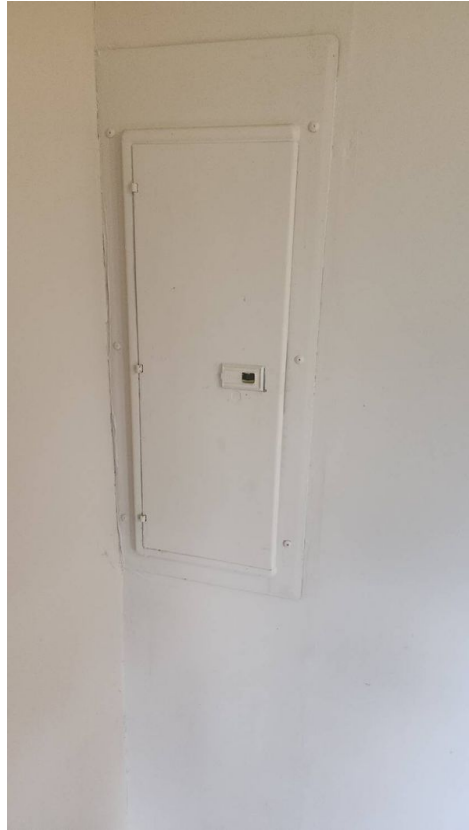
Panelboards & Breakers: Inspected Main Panelboard & Breakers

I inspected the electrical panelboards and over-current protection devices (circuit breakers and fuses).

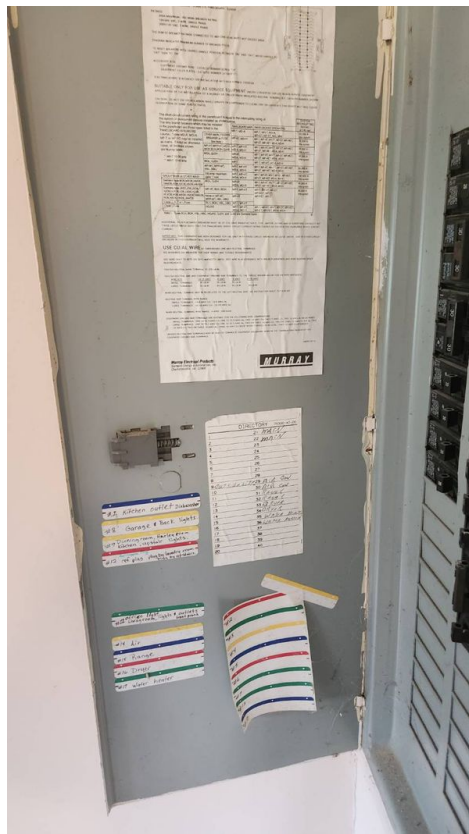
Electrical panel, AC was on so it is the one glowing, but normal temp.

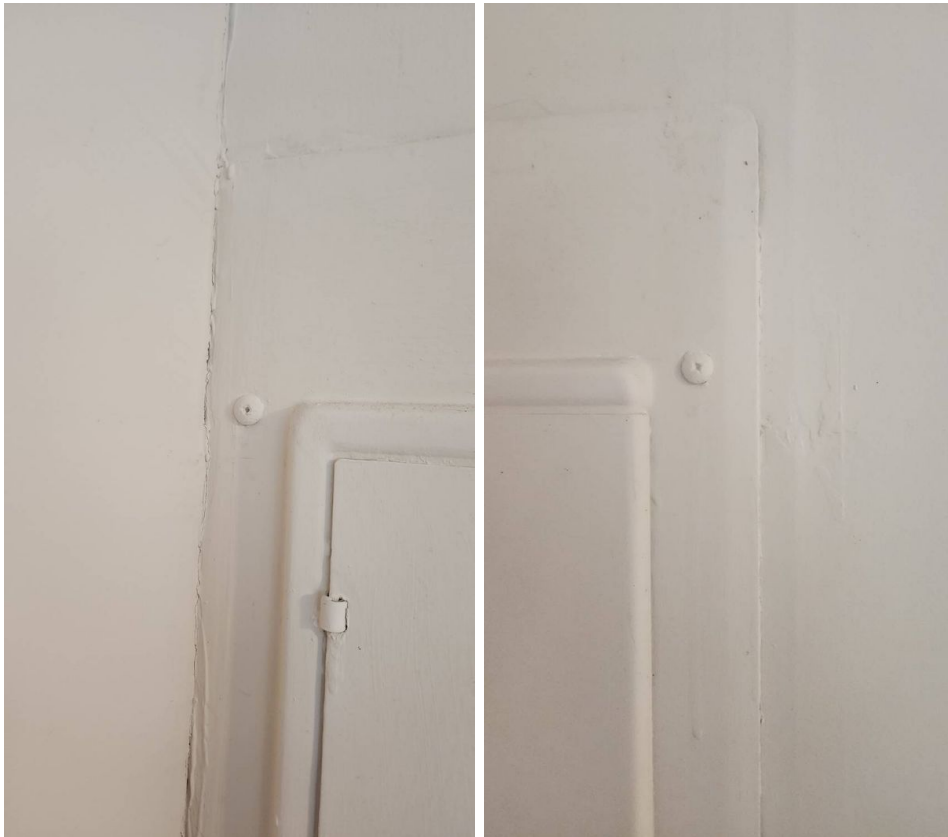
UNABLE TO INSPECT THE PANELBOARDS AND BREAKERS CLOSELY

I was restricted in my visual-only inspection in that I did not inspect closely all of the panelboards, components, connections, and breakers. I am an electrician and usually like to open the panel to give the best inspection I can, but I will inspect the electrical system according to the Home Inspection Standards of Practice as best as I can during the inspection.

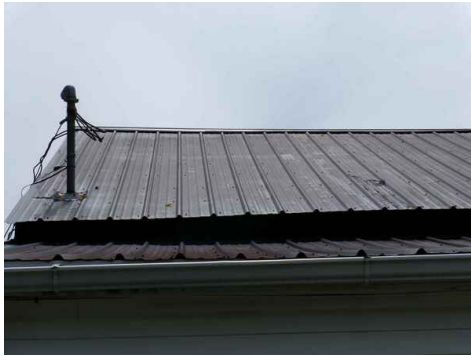
I observed indications of a major defect during the inspection. Major defect. Hazard. Correction and further evaluation is recommended.

The service entrance conductors are against the metal roofing. This could easily cut or wear the insulation and electrify the roofing metal or cause a short or fire.

Contact a qualified electrical contractor.

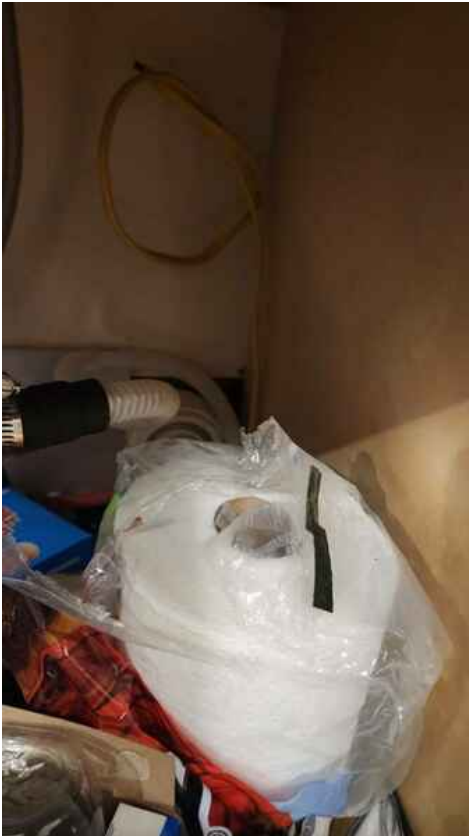
under kitchen sink

Contact a qualified electrical contractor.

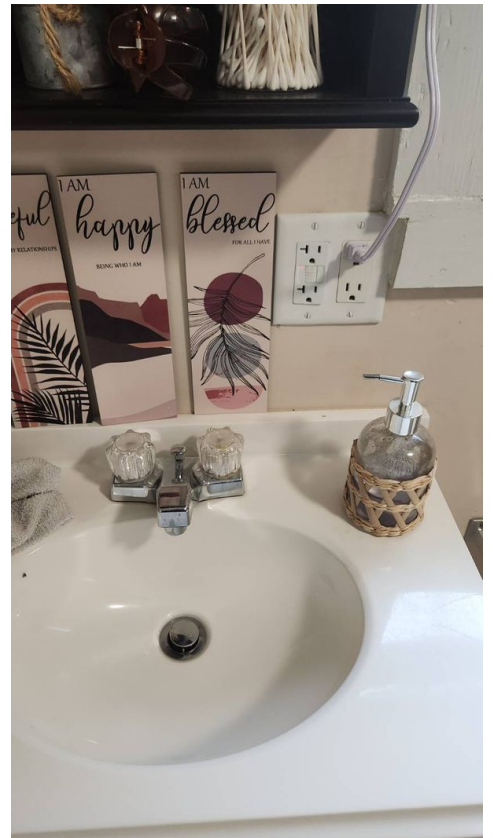
I observed a defect at the GFCI in the bathroom. It was not testing properly. Not functioning.

Contact a qualified electrical contractor.

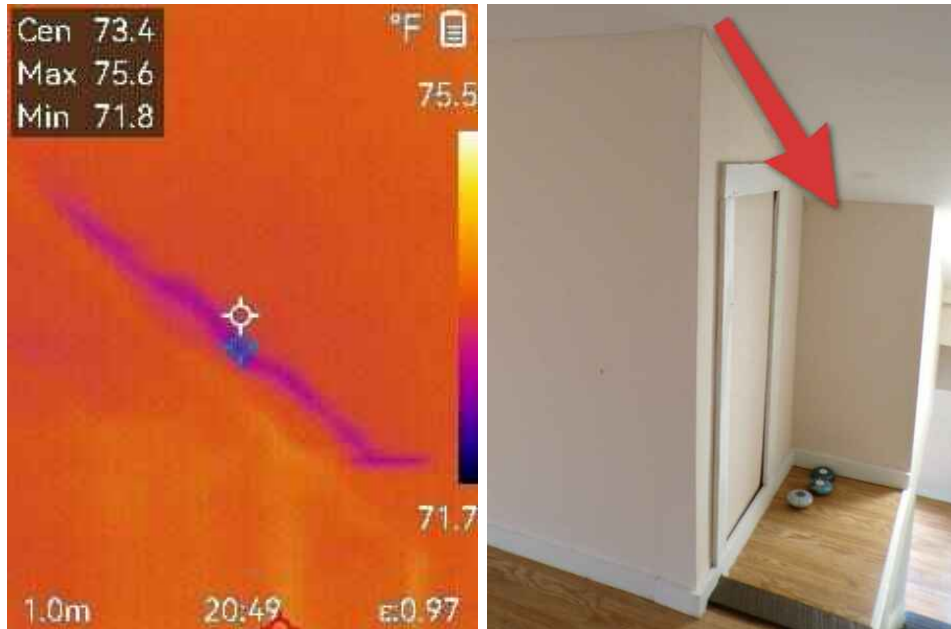
POSSIBLE WATER PENETRATION OBSERVED

I observed indications of the possibility of an active water penetration in the attic. Correction and further evaluation is recommended.

Contact a qualified roofing professional.

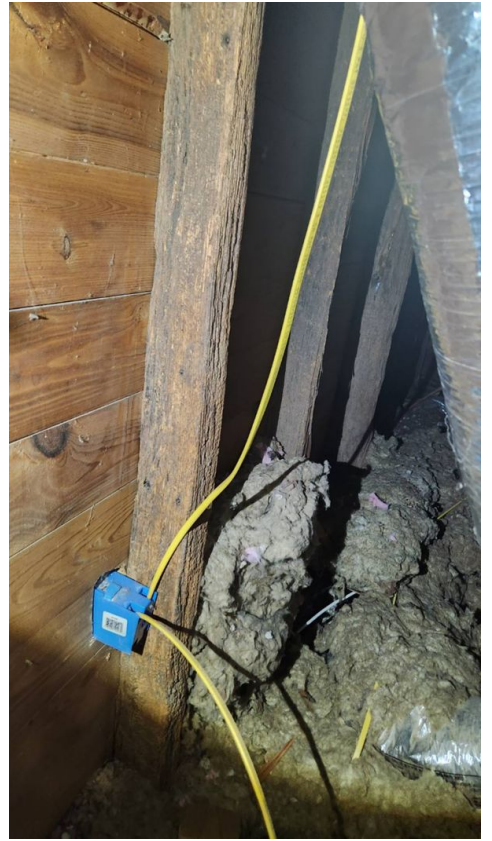
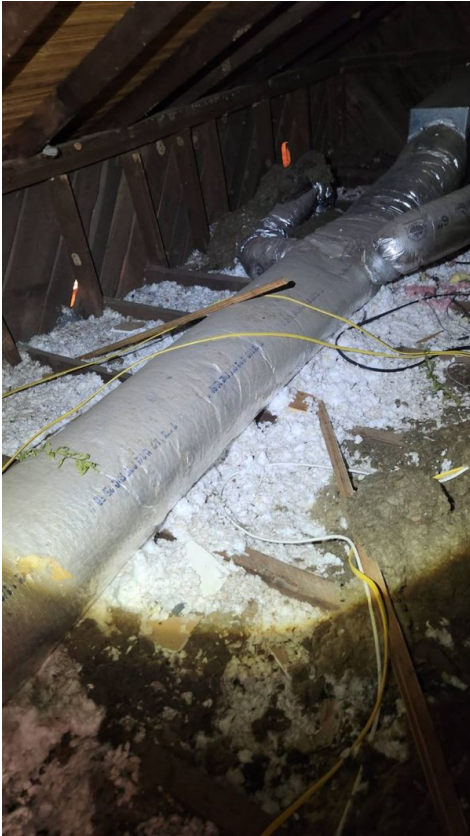
I observed indications of the general absence of insulation in the unfinished attic area.

Contact a qualified insulation contractor.

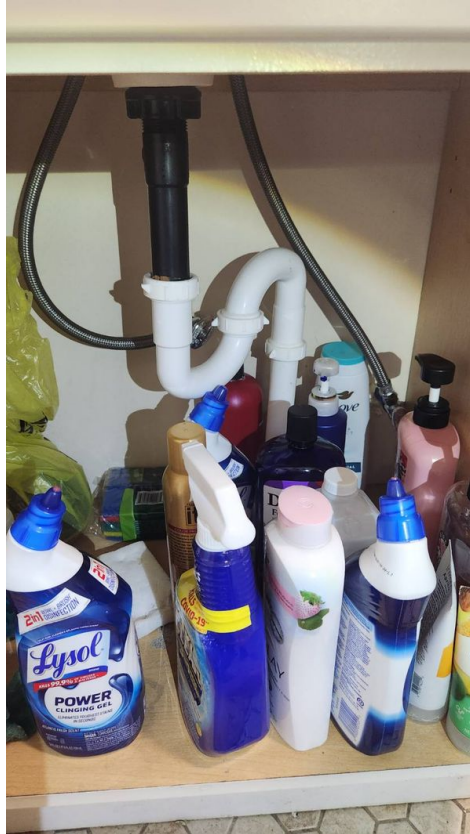
DEFECT AT S-TRAP

I observed indications of a defect at the sink drain trap. It is an S-trap, which are not permitted. It should be a P-trap. Please see illustration for details.

Recommended DIY Project

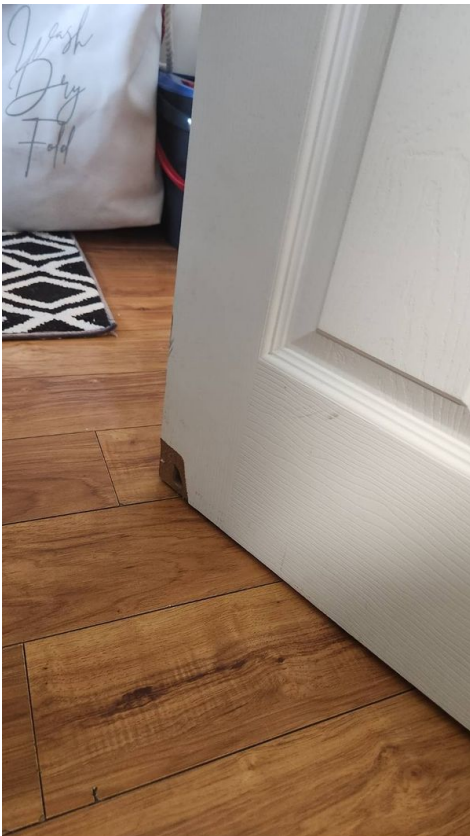
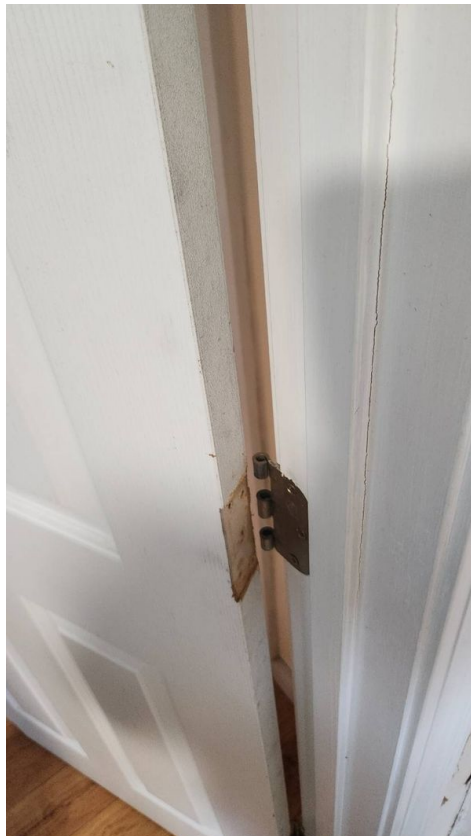
MINOR DAMAGE AT DOOR

I observed indications of minor damage at the bathroom door.

Recommended DIY Project

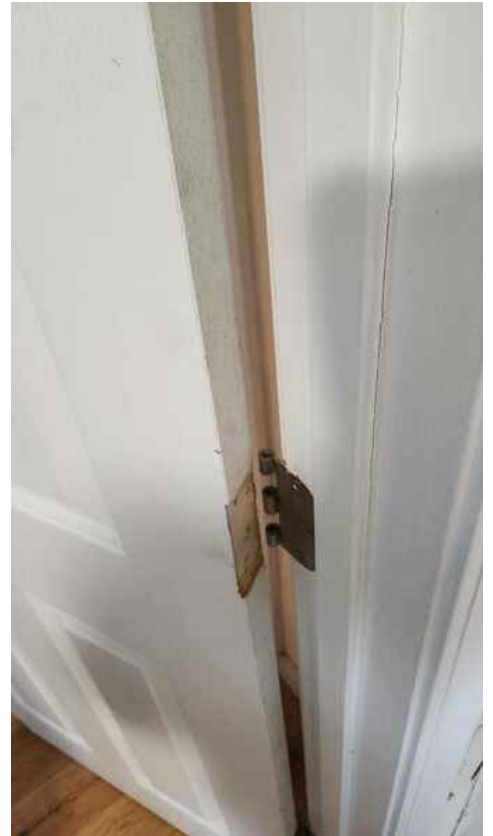
Bathroom door

DAMAGED DOOR HARDWARE

I observed damage to the door hardware.

Contact a handyman or DIY project

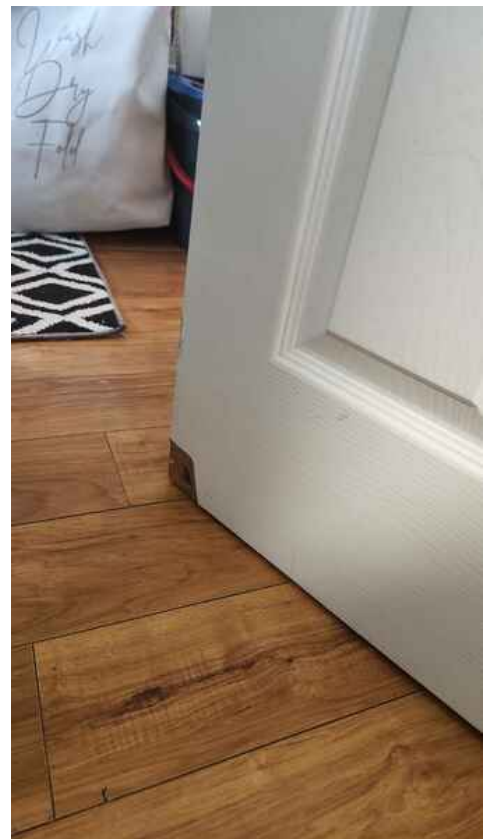
Bathroom

DAMAGED DOOR

I observed damage to the door.

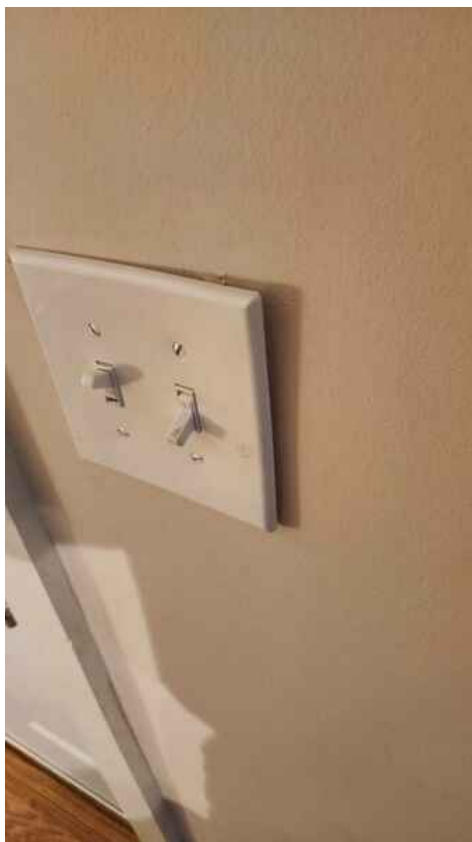
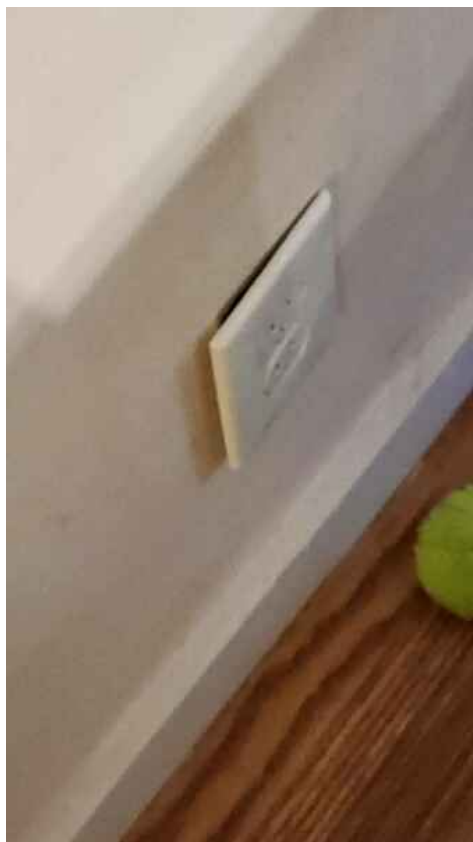
Boxes may not be at proper depth or some other problem that allows receptacle or switch to stick out from wall. Correction by an electrician recommended.

Contact a qualified electrical contractor.

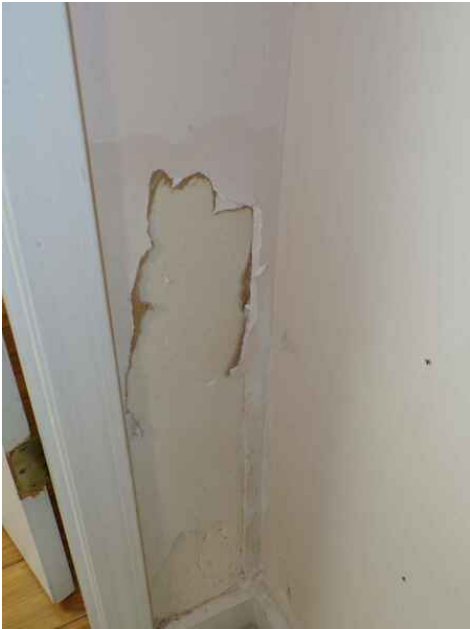
Bathroom

DAMAGED (GENERAL)

The home had general moderate damage visible at the time of the inspection. Recommend service by a qualified contractor.

Contact a qualified drywall contractor.

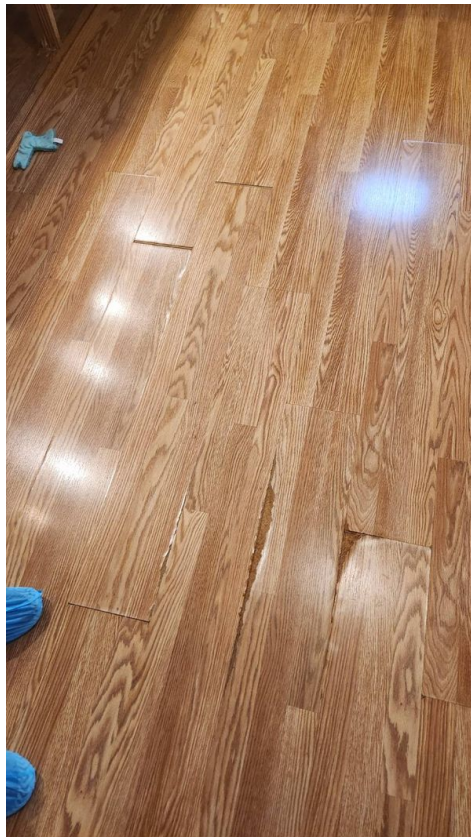
MOISTURE DAMAGE

Floors had areas of visible moisture damage. Recommend a qualified flooring contractor evaluate & repair areas of moisture.

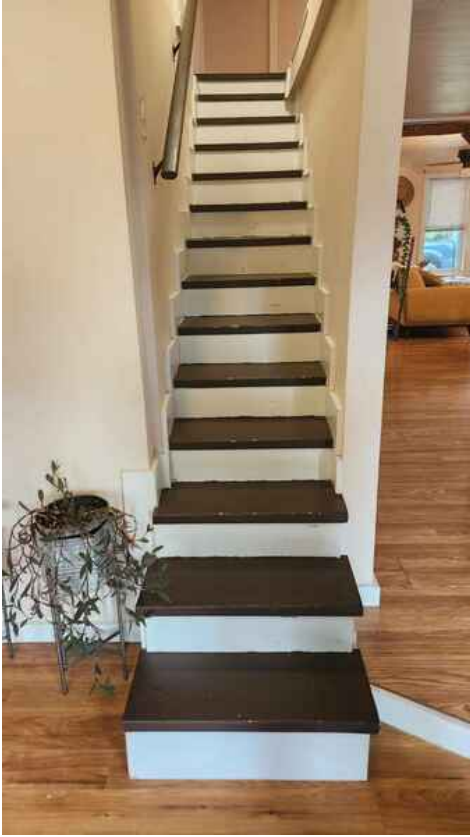
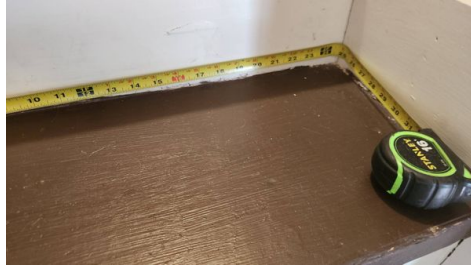
12.5.1 Stairs, Steps, Stoops, Stairways & Ramps

I observed that the width of the stairway (above the handrail) is less than the standard minimum of 36 inches.

Contact a qualified professional.

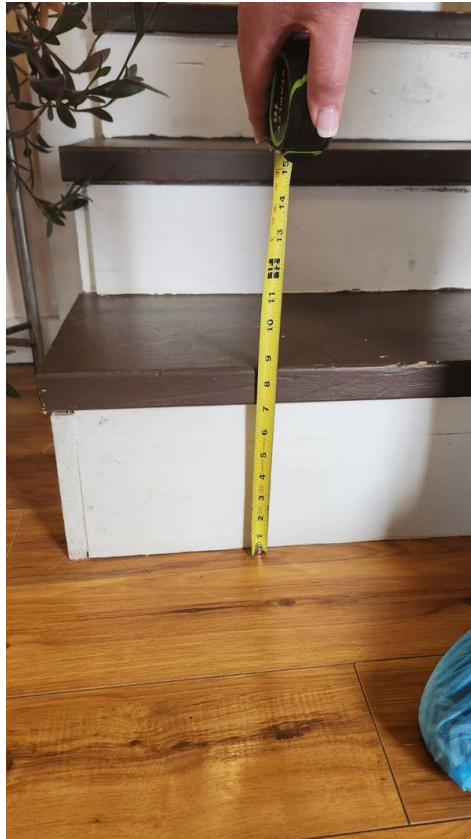
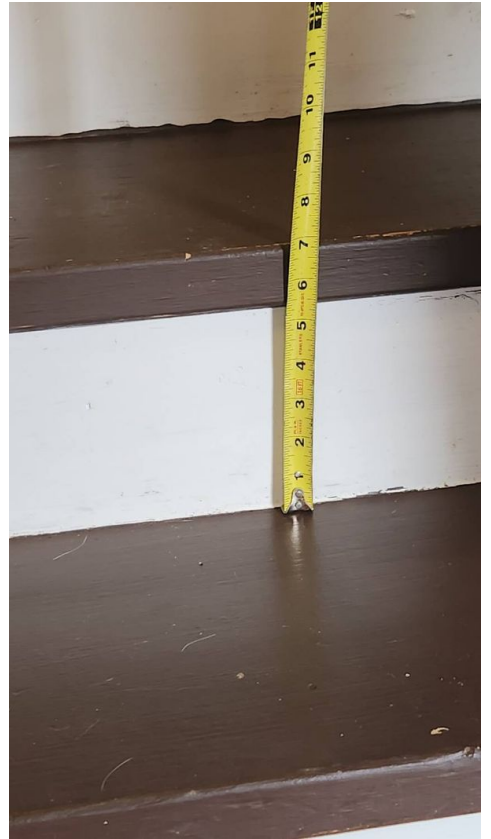
12.5.2 Stairs, Steps, Stoops, Stairways & Ramps

RISER HEIGHT TOO TALL (GREATER THAN 7 3/4")

I observed a defect at the stair riser height.

The riser height maximum is 7 3/4 inches measured vertically between the stair treads. This poses a trip hazard.

Contact a qualified professional.

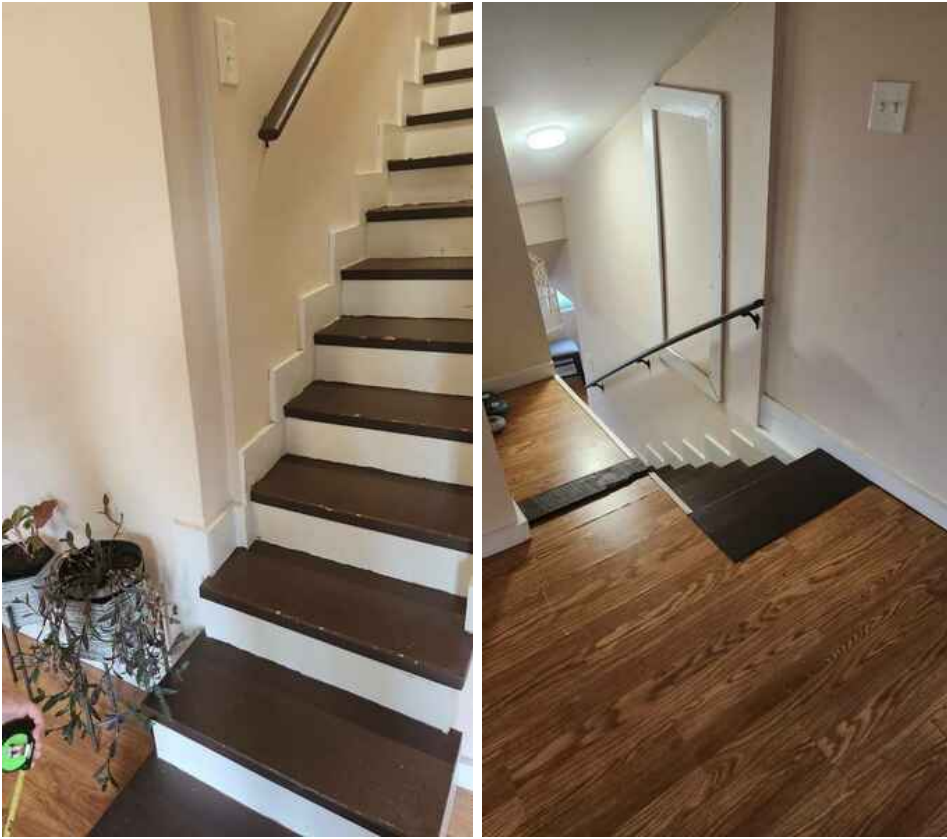
12.6.1 Railings, Guards & Handrails

MISSING HANDRAIL

I observed a missing handrail.

There is more than one step here, and I recommend installing a handrail for safety.

Contact a qualified professional.

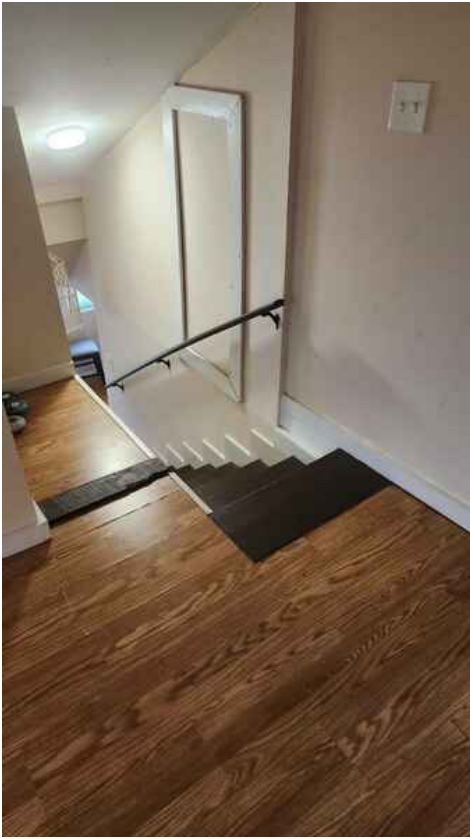
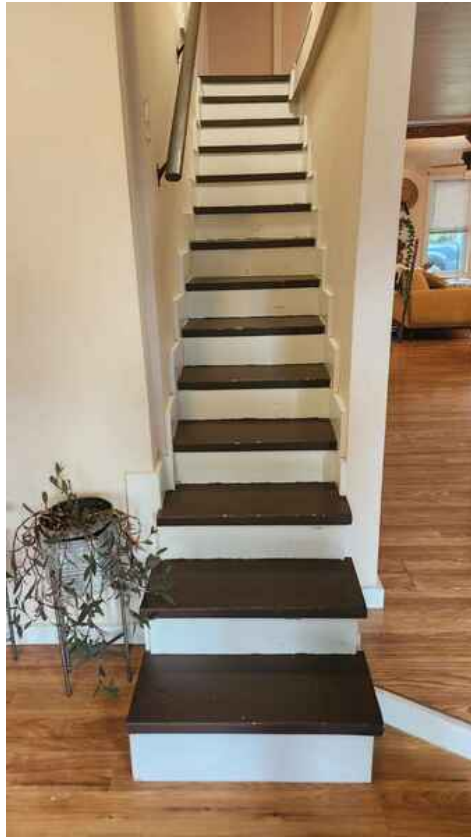
12.6.2 Railings, Guards & Handrails

HANDRAIL IS NOT CONTINUOUS

I observed that the handrail is not continuous. It should be.
