KEVIN'S INSPECTIONS

1234 Main Street
Columbia, TN 38401

Buyer Name
01/30/2025 9:00AM

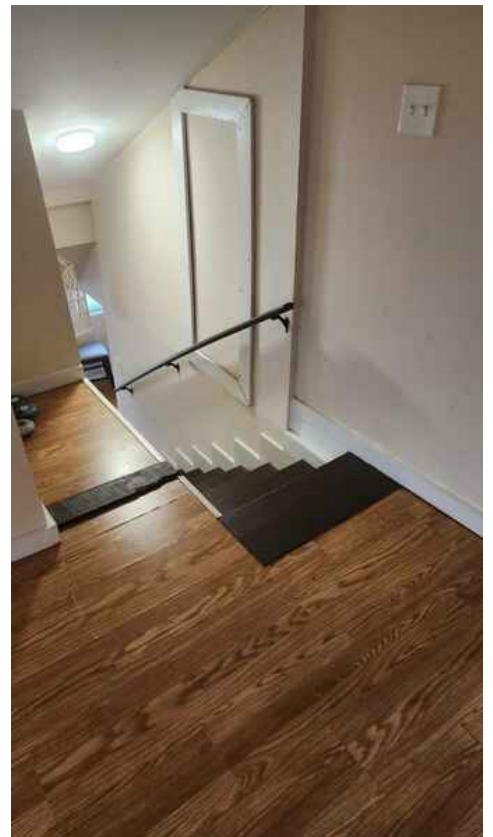
12.6.3 Railings, Guards & Handrails

MISSING GUARDRAIL

I observed an area that is in need of a guardrail for safety. Recommend installation of a guardrail by qualified professional.

Contact a qualified professional.

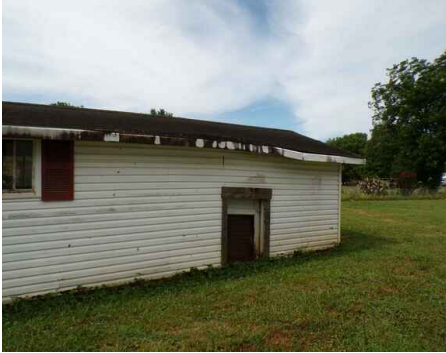
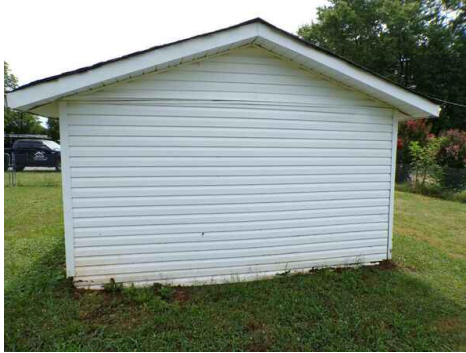
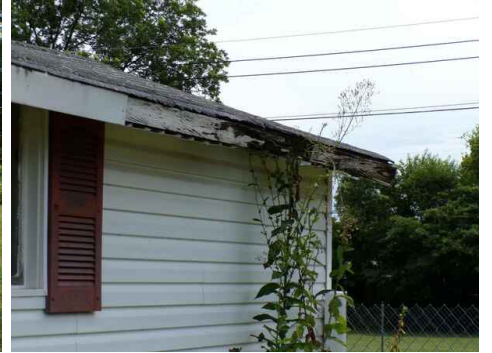
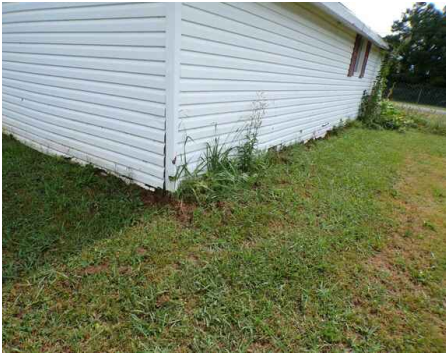
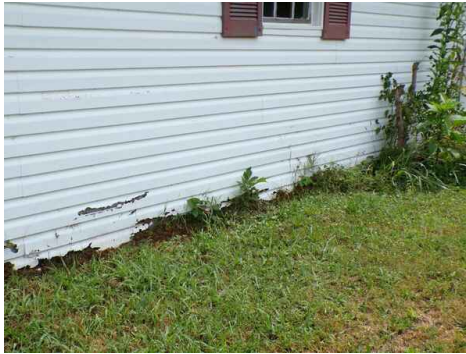
The garage was not accessible and was not inspected because of being locked. From what I observed on the outside, this garage has a significant amount of defects.

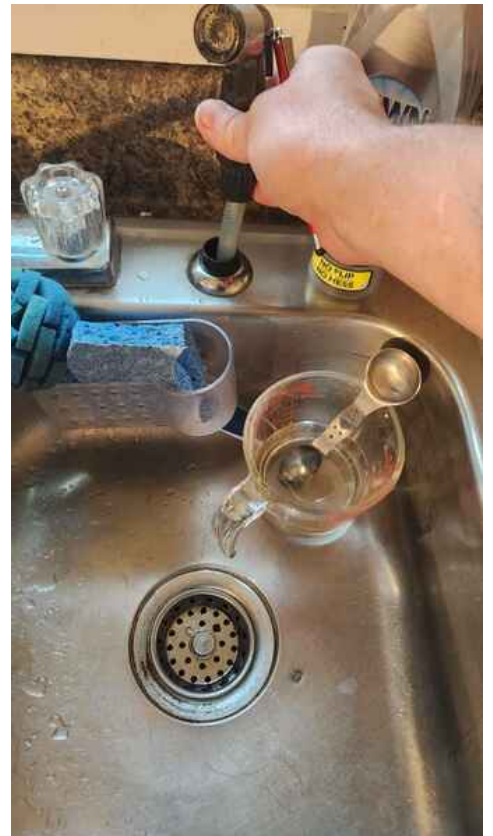
Sprayer wand ring in broken or loose

Contact a qualified plumbing contractor.

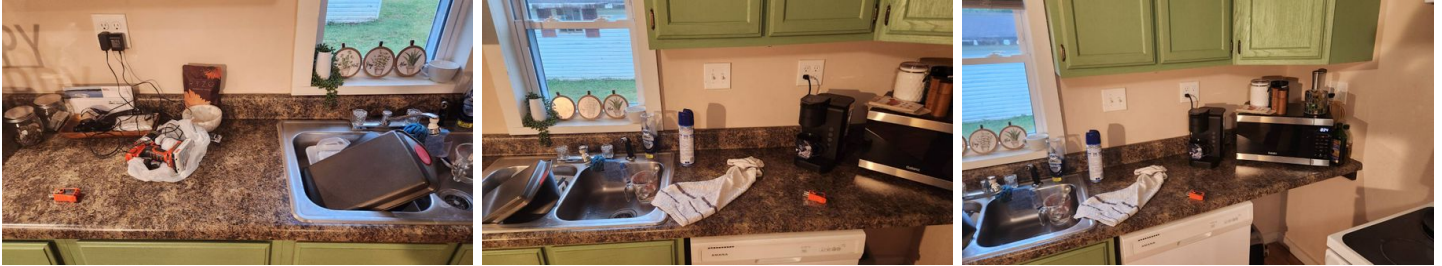
MISSING GFCI PROTECTION

I observed indications of missing GFCI protection in the kitchen. All kitchen counter receptacles are required to be GFCI protected.

Contact a qualified electrical contractor.
